# Coal Operations Depot, Hexham

## Concept Design Report

Aurizon Operations Limited

07 April 2022

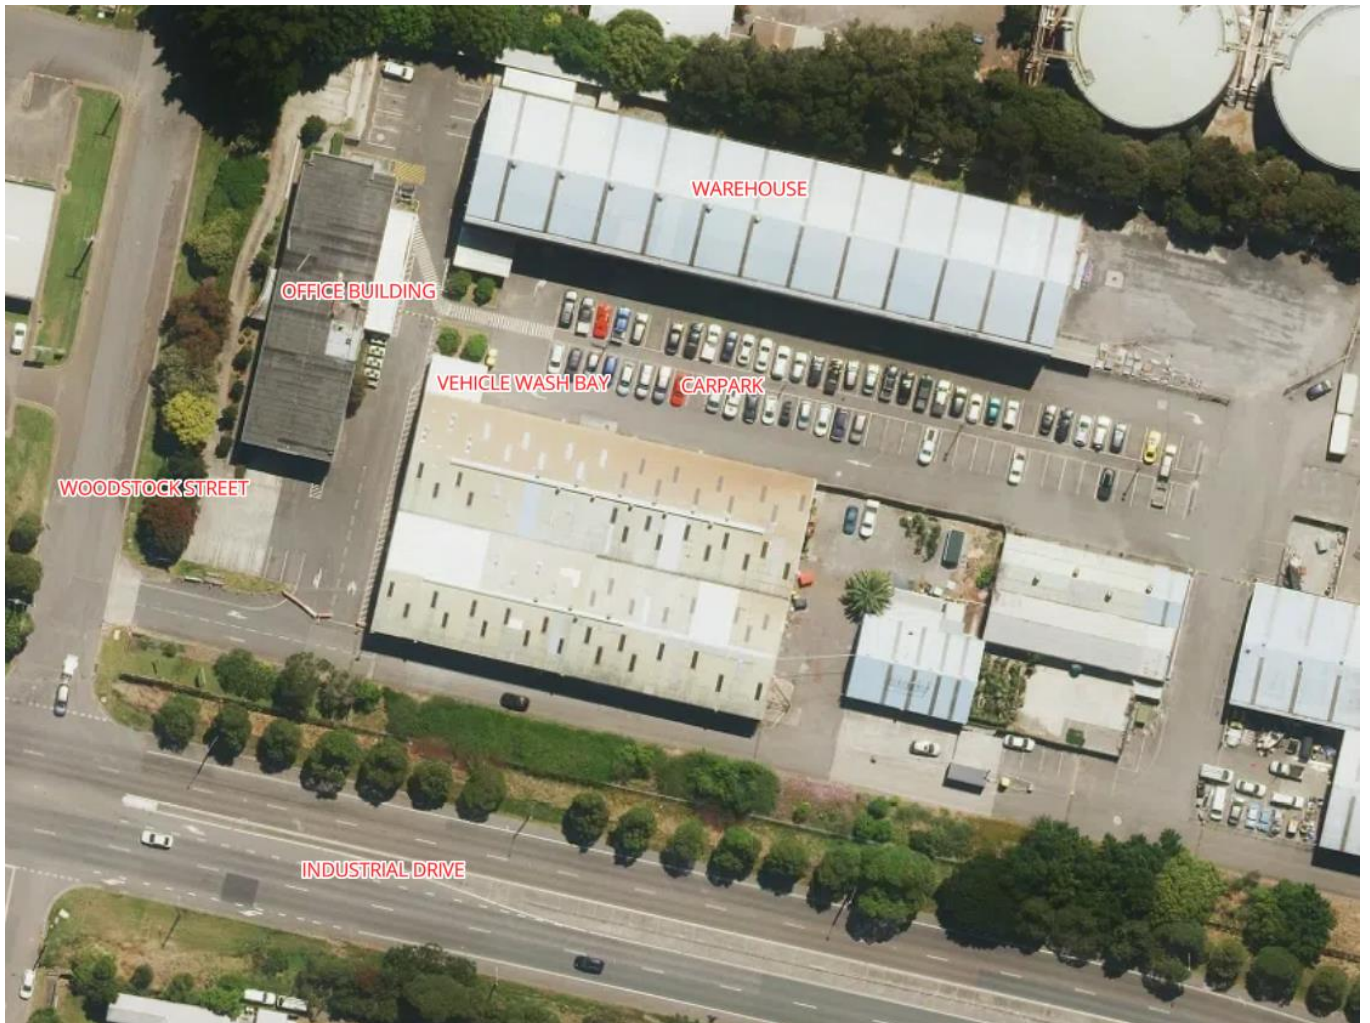
Figure 2.1 Existing facility at Mayfield, NSW

The existing Aurizon operations depot and warehouse facilities are located at 121 Woodstock St, Mayfield, NSW as shown in Figure 2.1 below. The warehouse is currently used to store parts on shelves and is accessed by a forklift. The office building is a structure previously built for other purposes. The current space includes the crew sign on space, multiple offices and meeting rooms, an operations work space, a support services work space, lunch rooms and kitchenettes and amenities.

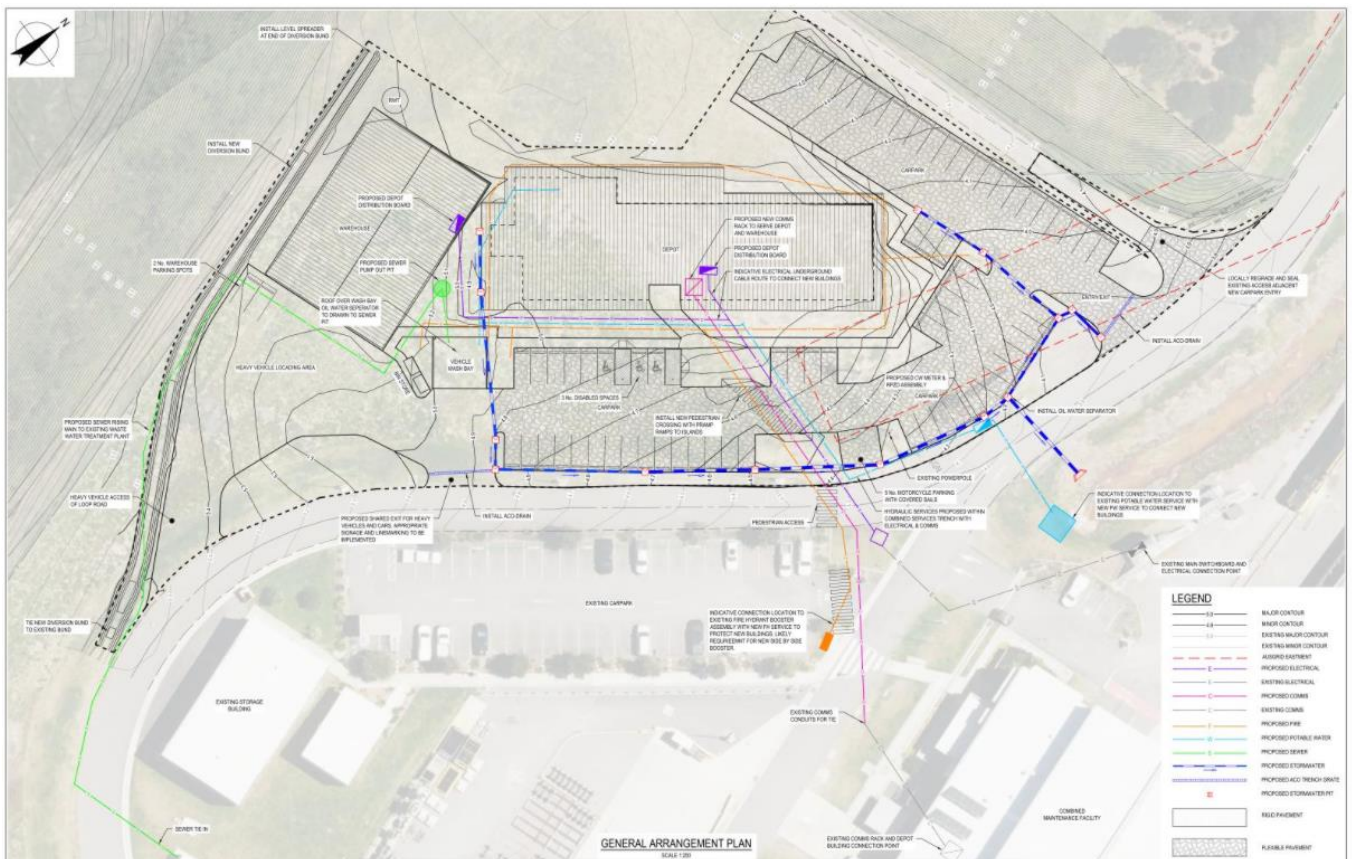
Figure 5.1 Site layout

An existing power line and power poles accommodating a pole mounted substation was highlighted as encumbering the site early on. The carpark has been designed around this constraint, retaining the pole mounted substation, negating the need for any relocation works. The Ausgrid easement is 15 m wide and crosses the new carpark.

The new operations depot office building is located adjacent to the carpark, to the west, with the new warehouse structure located west of the operations depot office building, adjoining the loading and unloading zone. Two additional carparks have been located adjacent the warehouse. A figure of the site layout can be seen below.

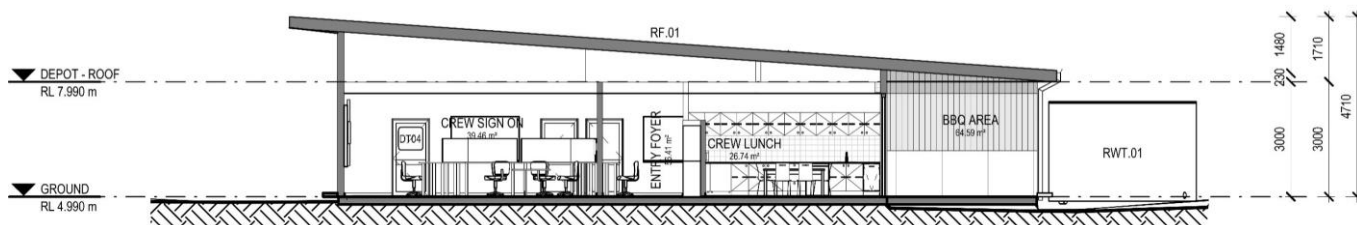
Figure 6.1 Indicative office structural section

The built form of the depot will consist of a lightly loaded single storey office, shown below in Figure 6.1, amenities and driver shift sign-on building. The structure will be predominantly constructed of timber framing with concrete footings and ground slab. Structural steel beams and columns will be utilised to provide column free spaces where necessary and select walls will be used to brace the structure against lateral loading.

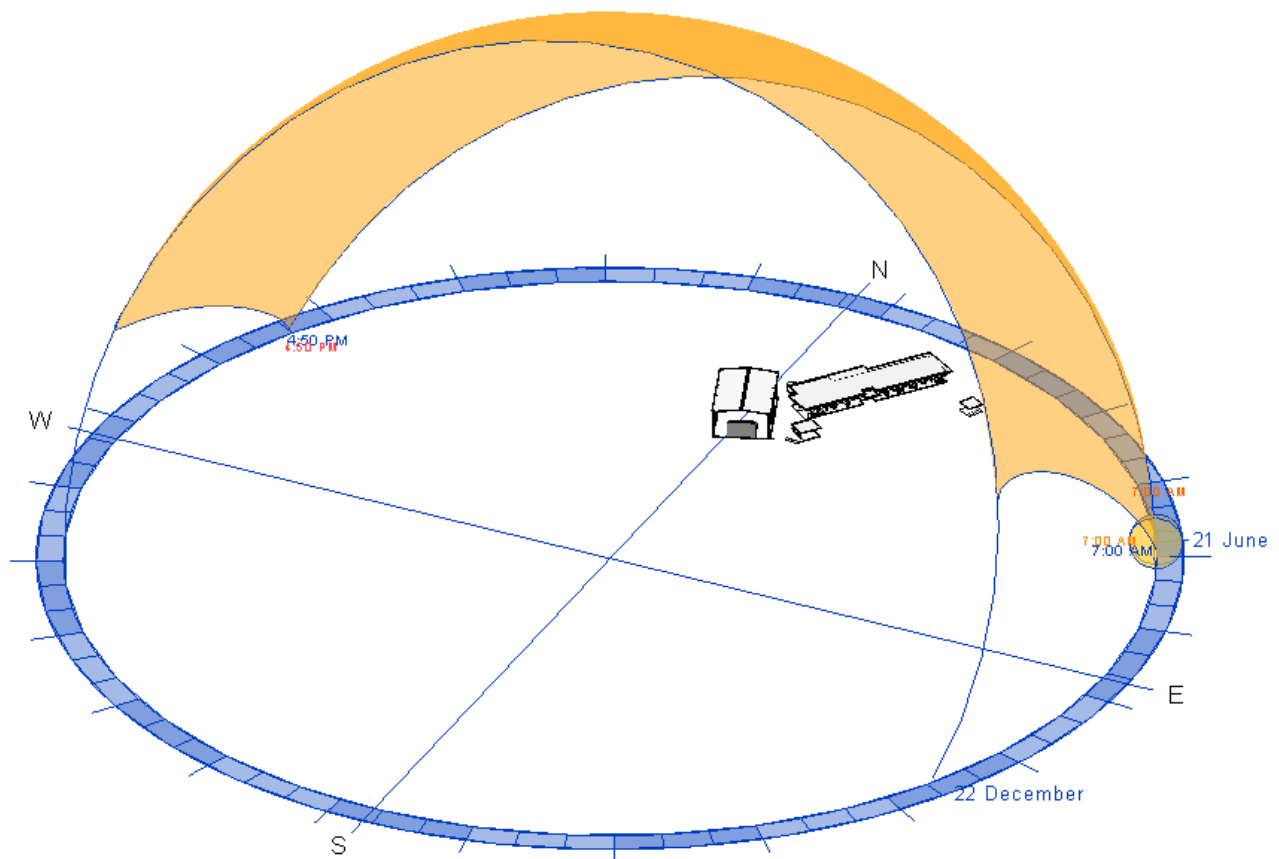
Figure 7.1 Sun path analysis diagram

NSW Adapt climate change projects that the mean temperatures will increase by 0.7 °C and continue to rise by 2.1 °C by 2070. The region is also expected to have an increase in the number of annual hot days, while the number of annual cold night will decrease. Future climate change impacts should be considered by designers in the next stage to ensure that building elements and systems are designed and selected to be resilient to future climate change.

The site location is exposed and not shaded by surrounding buildings or vegetation. Whilst this impacts building thermal performance it does provide opportunity to introduce on site energy generation and is ideal location for solar PV adoption.

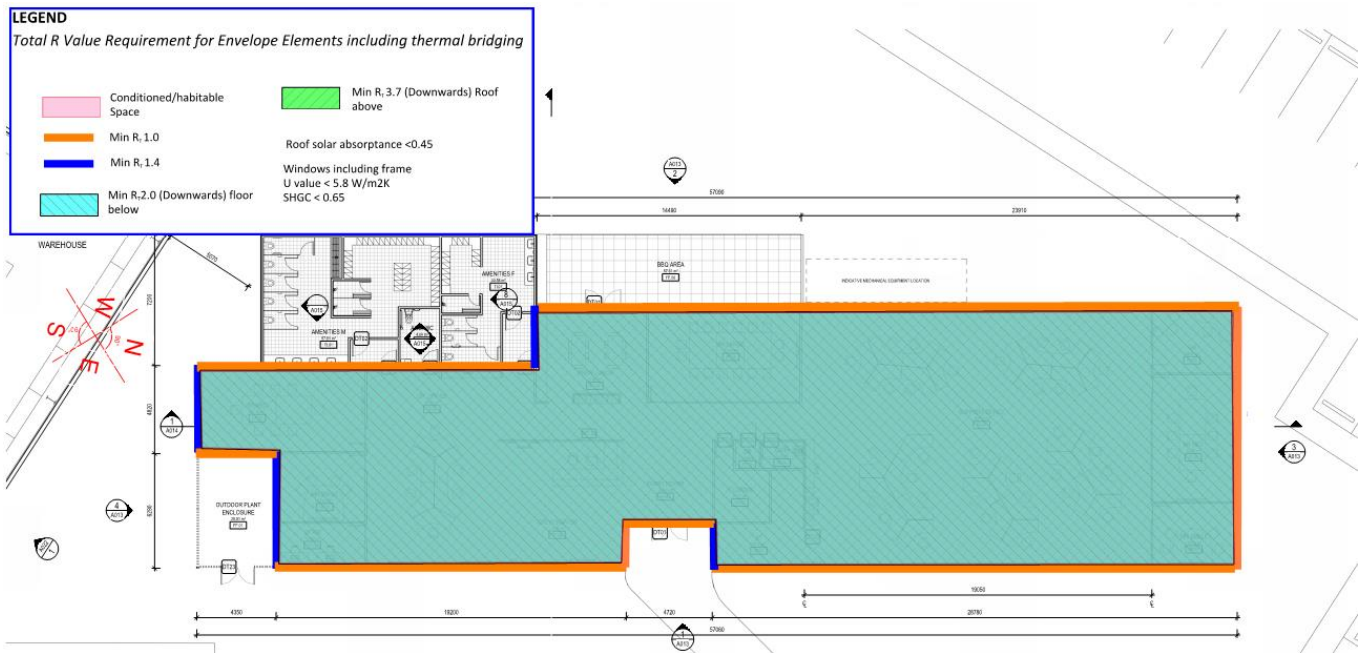
Figure 7.2 Thermal performance mark up

The project has adopted a number of passive design principles to manage heat gains and losses. Due to other site constraints influencing the orientation, it was not possible to adopt an optimised massing and orientation. However, heat gains and losses will be managed through the following:

1. Limiting the extent of glazed elements. The project currently has a wall / window ratio of approximately 79% on all elevations.
2. Shading devices have been considered and implemented on the northern and western façade to prevent direct solar heat gains. The warehouse building will also provide shade to western elevation of the depot building.
3. Building envelope thermal performance has been determined. Increases over minimum Sec J performance should be considered to further reduce building energy use. Refer below Figure 7.2 and Table 7.1.
4. Warehouse spaces are using natural ventilation.

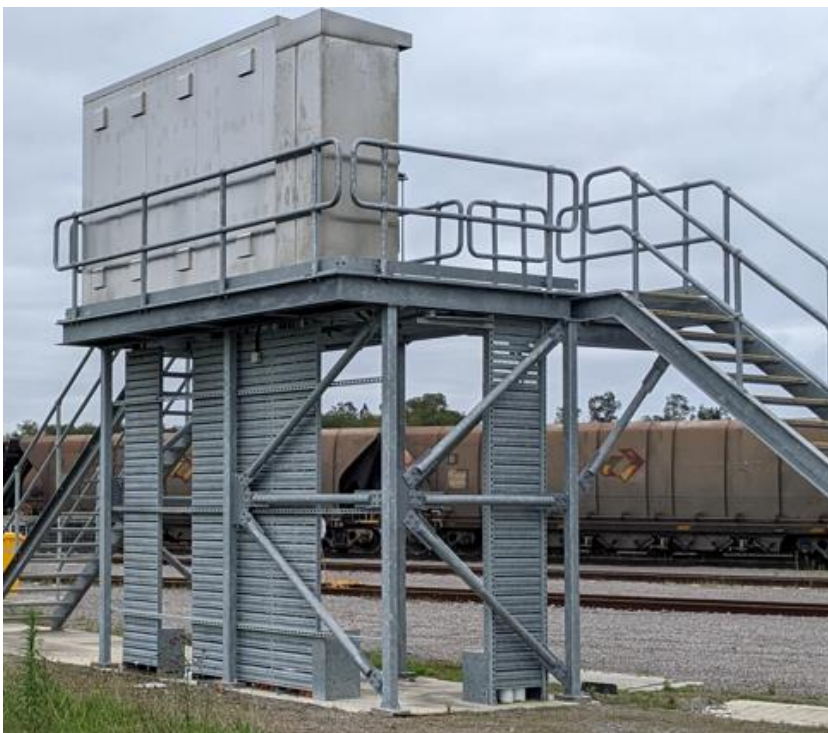
Figure 8.1 CMF main switchboard

The existing combined maintenance facility is served by a 400 kVA Ausgrid pole top substation (Asset number HP63467). The site is connected via a private pole with consumer mains then reticulating underground to a main switchboard installed on a service platform to the West of the CMF building. Figure 8.1 Below shows the CMF main switchboard (MSB) located on the service platform. The main switchboard supplies the CMF main distribution board as well as smaller services to a signalling hut, service vehicle garage and a yard lighting distribution section. On review of the facilities energy bills, the main switchboard has a recorded peak demand of 120 kVA which was recorded in October 2020. The existing main switchboard has 3 spare 250 A circuit breaker spaces as well as a single 400 A circuit breaker space.

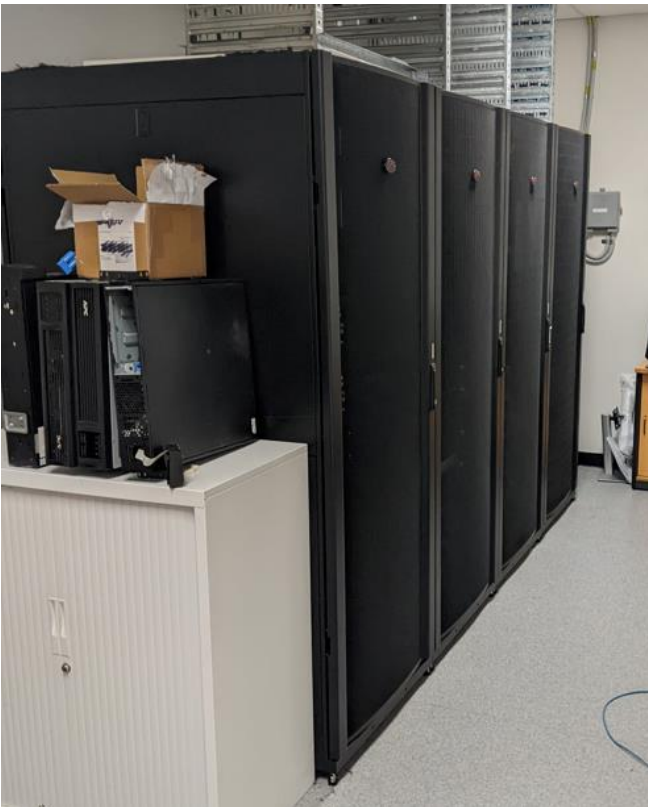
Figure 8.2 CMF communications room

The CMF communications network is serviced by an NBN fibre service with the main communications room located on the second floor of the office area. Figure 8.2 below shows the 4 racks within the existing communications room. There are spare ports within the fibre distribution panel to service the proposed building. The communications room also houses the security systems headend equipment that services the electronic access control system as well as the CCTV cameras located around the building and site.

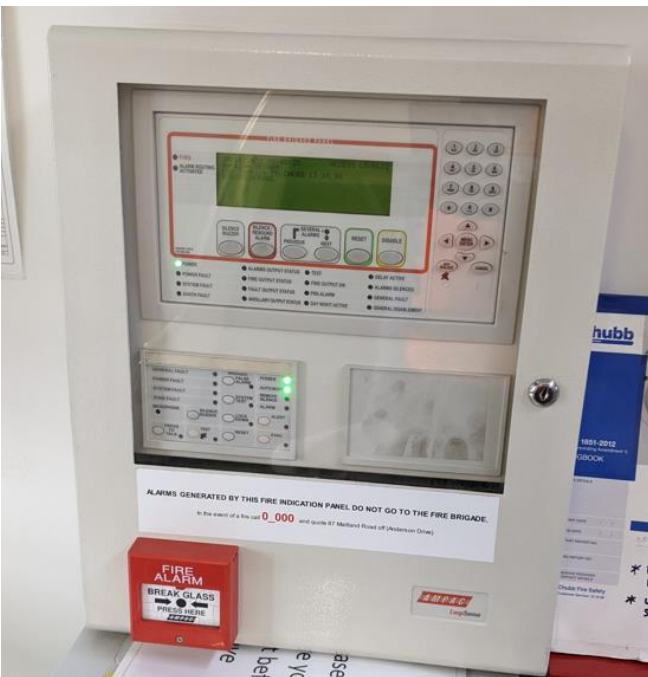
Figure 8.3 CMF FIP

The CMF is serviced by a fire detection and alarm system for the 2 storey office area only. The Fire Detection, Control and Indicating Equipment (FDCIE) notes that the system is not connected to the fire brigade and provides local alarm only. Figure 8.3 shows the existing FIP installed within the CMF. Based on the size and classification of the building it is expected that the CMF office alarm system has been installed as an Aurizon preference and is not required to meet BCA fire detection and warning system requirements.

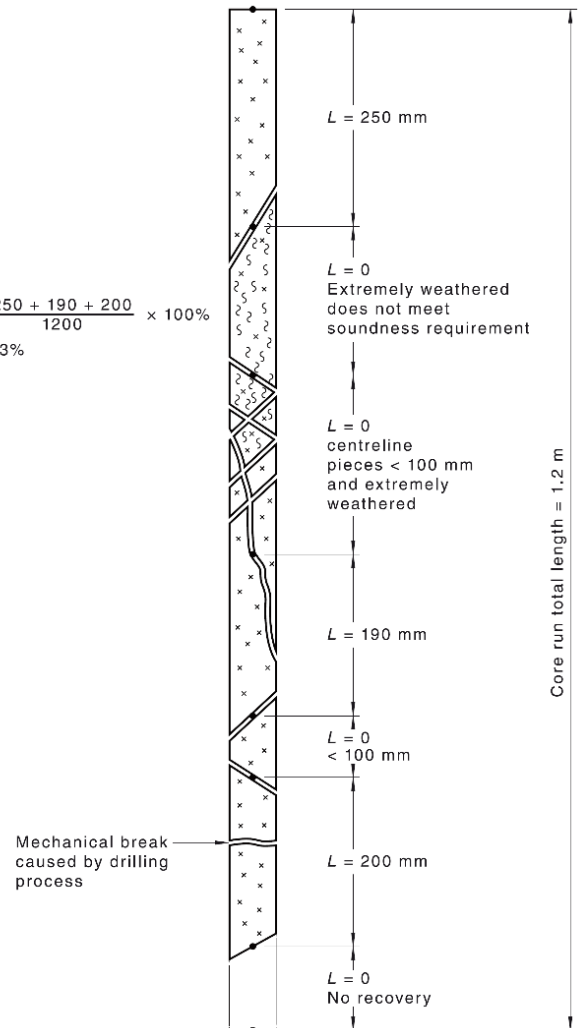
### RQD measurement procedure

$$RQD = \frac{\sum \text{Length of sound core pieces} > 100 \text{ mm in length}}{\text{Length of core run}} \times 100\%$$

$$RQD = \frac{250 + 190 + 200}{1200} \times 100\% = 53\%$$

(reproduced from Figure 13, Clause 6.2.9.4, AS 1726-2017, Geotechnical site investigations)

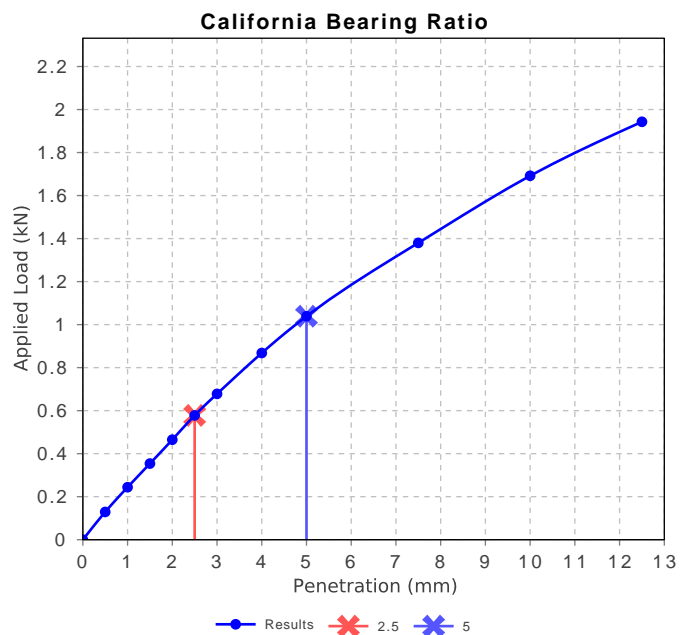
California Bearing Ratio (AS 1289 6.1.1 & 2.1.1)		Min	Max
CBR taken at	5 mm		
CBR %	5		
Method of Compactive Effort	Standard		
Method used to Determine MDD	AS 1289 5.1.1 & 2.1.1		
Method used to Determine Plasticity	vt		
Maximum Dry Density (t/m <sup>3</sup> )	1.42		
Optimum Moisture Content (%)	15.5		
Laboratory Density Ratio (%)	99.0		
Laboratory Moisture Ratio (%)	93.0		
Dry Density after Soaking (t/m <sup>3</sup> )	1.39		
Field Moisture Content (%)			
Moisture Content at Placement (%)	14.5		
Moisture Content Top 30mm (%)	22.3		
Moisture Content Rest of Sample (%)	17.4		
Mass Surcharge (kg)	4.5		
Soaking Period (days)	4		
Curing Hours	120.0		
Swell (%)	1.5		
Oversize Material (mm)	19		
Oversize Material Included	Excluded		
Oversize Material (%)	15.9		
Variation from Test Method	Moulded dry of specified tolerance limit.

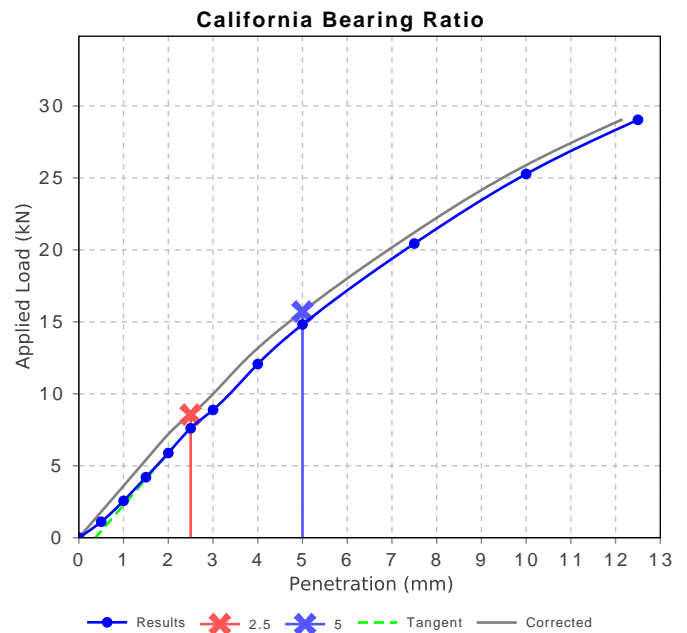
California Bearing Ratio (AS 1289 6.1.1 & 2.1.1)		Min	Max
CBR taken at	5 mm		
CBR %	80		
Method of Compactive Effort	Standard		
Method used to Determine MDD	AS 1289 5.1.1 & 2.1.1		
Method used to Determine Plasticity	vt		
Maximum Dry Density (t/m <sup>3</sup> )	1.89		
Optimum Moisture Content (%)	11.5		
Laboratory Density Ratio (%)	102.0		
Laboratory Moisture Ratio (%)	75.5		
Dry Density after Soaking (t/m <sup>3</sup> )	1.93		
Field Moisture Content (%)			
Moisture Content at Placement (%)	8.8		
Moisture Content Top 30mm (%)	10.7		
Moisture Content Rest of Sample (%)	9.5		
Mass Surcharge (kg)	4.5		
Soaking Period (days)	4		
Curing Hours	99.7		
Swell (%)	0.0		
Oversize Material (mm)	19		
Oversize Material Included	Excluded		
Oversize Material (%)	16.9		
Variation from Test Method	Moulded dry of specified tolerance limit.

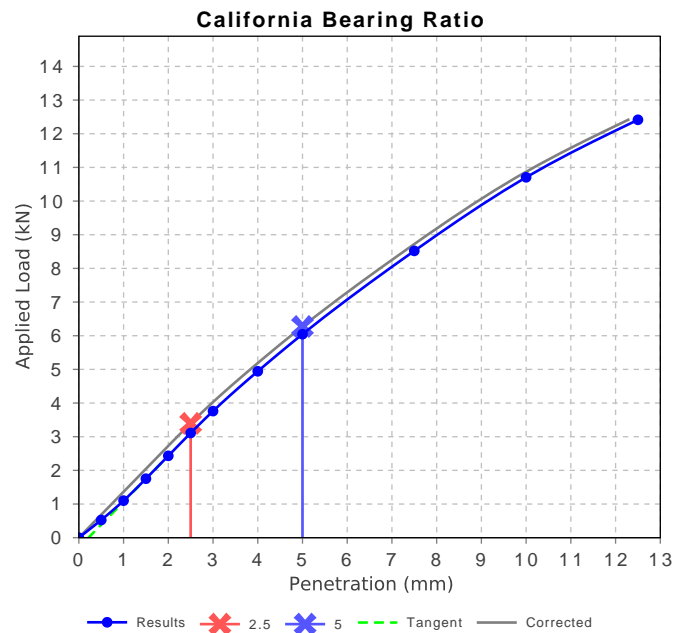
California Bearing Ratio (AS 1289 6.1.1 & 2.1.1)		Min	Max
CBR taken at	5 mm		
CBR %	30		
Method of Compactive Effort	Standard		
Method used to Determine MDD	AS1289.5.1.1		
Method used to Determine Plasticity	Vt		
Maximum Dry Density (t/m <sup>3</sup> )	2.01		
Optimum Moisture Content (%)	9.5		
Laboratory Density Ratio (%)	98.5		
Laboratory Moisture Ratio (%)	100.0		
Dry Density after Soaking (t/m <sup>3</sup> )	1.98		
Field Moisture Content (%)			
Moisture Content at Placement (%)	9.3		
Moisture Content Top 30mm (%)	12.5		
Moisture Content Rest of Sample (%)	10.6		
Mass Surcharge (kg)	4.5		
Soaking Period (days)	4		
Curing Hours	483.1		
Swell (%)	0.0		
Oversize Material (mm)	19		
Oversize Material Included	Excluded		
Oversize Material (%)	0

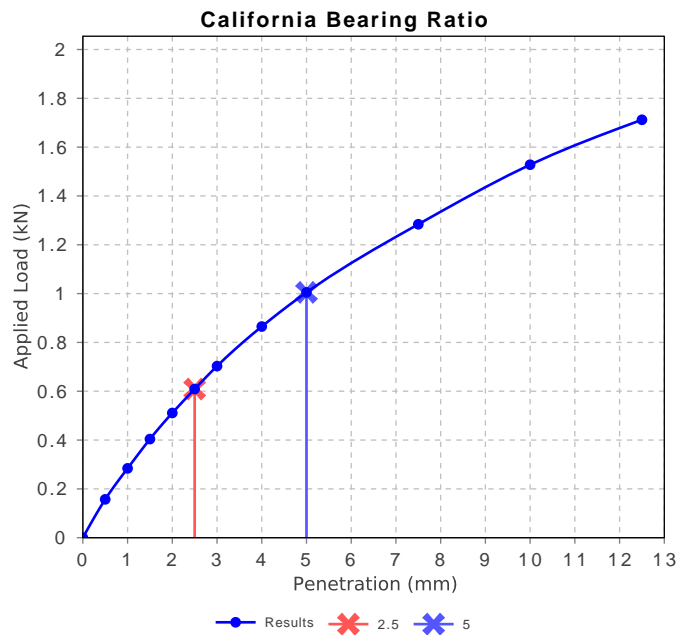
California Bearing Ratio (AS 1289 6.1.1 & 2.1.1)		Min	Max
CBR taken at	5 mm		
CBR %	5		
Method of Compactive Effort	Standard		
Method used to Determine MDD	AS 1289 5.1.1 & 2.1.1		
Method used to Determine Plasticity	vt		
Maximum Dry Density (t/m <sup>3</sup> )	1.69		
Optimum Moisture Content (%)	17.0		
Laboratory Density Ratio (%)	99.0		
Laboratory Moisture Ratio (%)	101.0		
Dry Density after Soaking (t/m <sup>3</sup> )	1.64		
Field Moisture Content (%)			
Moisture Content at Placement (%)	17.0		
Moisture Content Top 30mm (%)	21.7		
Moisture Content Rest of Sample (%)	18.2		
Mass Surcharge (kg)	4.5		
Soaking Period (days)	4		
Curing Hours	142.1		
Swell (%)	2.0		
Oversize Material (mm)	19		
Oversize Material Included	Excluded		
Oversize Material (%)	8.0

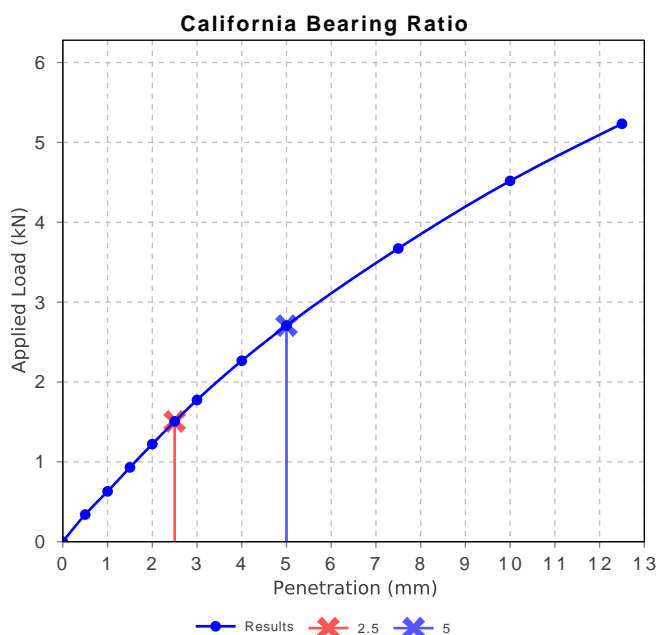
California Bearing Ratio (AS 1289 6.1.1 & 2.1.1)		Min	Max
CBR taken at	5 mm		
CBR %	14		
Method of Compactive Effort	Standard		
Method used to Determine MDD	AS 1289 5.1.1 & 2.1.1		
Method used to Determine Plasticity	vt		
Maximum Dry Density (t/m <sup>3</sup> )	1.74		
Optimum Moisture Content (%)	14.5		
Laboratory Density Ratio (%)	98.5		
Laboratory Moisture Ratio (%)	101.5		
Dry Density after Soaking (t/m <sup>3</sup> )	1.71		
Field Moisture Content (%)			
Moisture Content at Placement (%)	14.9		
Moisture Content Top 30mm (%)	15.1		
Moisture Content Rest of Sample (%)	15.5		
Mass Surcharge (kg)	4.5		
Soaking Period (days)	4		
Curing Hours	144.0		
Swell (%)	0.0		
Oversize Material (mm)	19		
Oversize Material Included	Excluded		
Oversize Material (%)	17.0
