## Aboriginal Due Diligence Report

Aurizon

Hexham Depot Modification  
22 March 2022

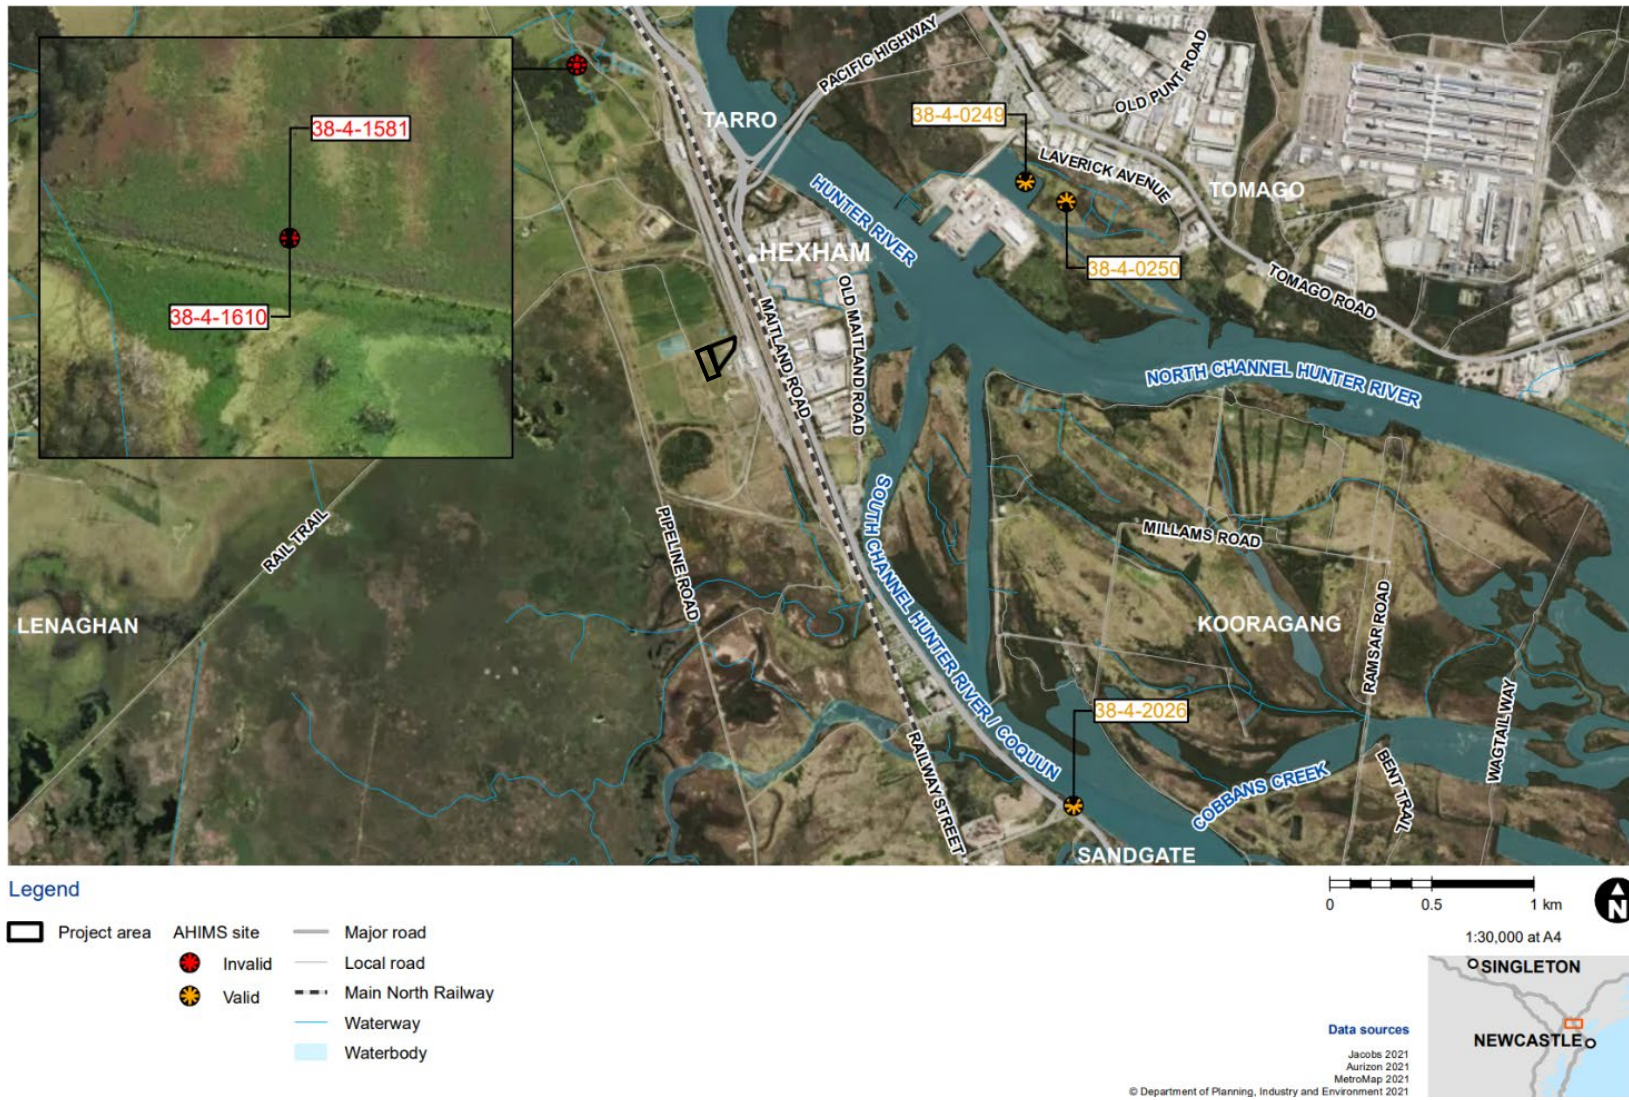
**Figure 5-1. AHIMS search results**  
 AHIMS sites within the radius of the project

**Table 5-1. AHIMS search results**

AHIMS ID	Site Name	Datum	Coordinates (Zone 56) Eastings	Coordinates (Zone 56) Northings	Site Features
38-4-0249	T 8;	AGD	378200	6367400	Open camp site
38-4-0250	T 8_A_(T9);	AGD	378400	6367300	Open camp site
38-4-2026	HS-IF-1	GDA	378437	6364343	One recorded artefact
38-4-1581	HS PCD 1 (not a site)	GDA	376000	6367970	Potential Archaeological Deposit Site had been deleted
38-4-1581	HS PCD 1(not a site)	GDA	376000	6367970	Potential Archaeological Deposit Site had been deemed invalid

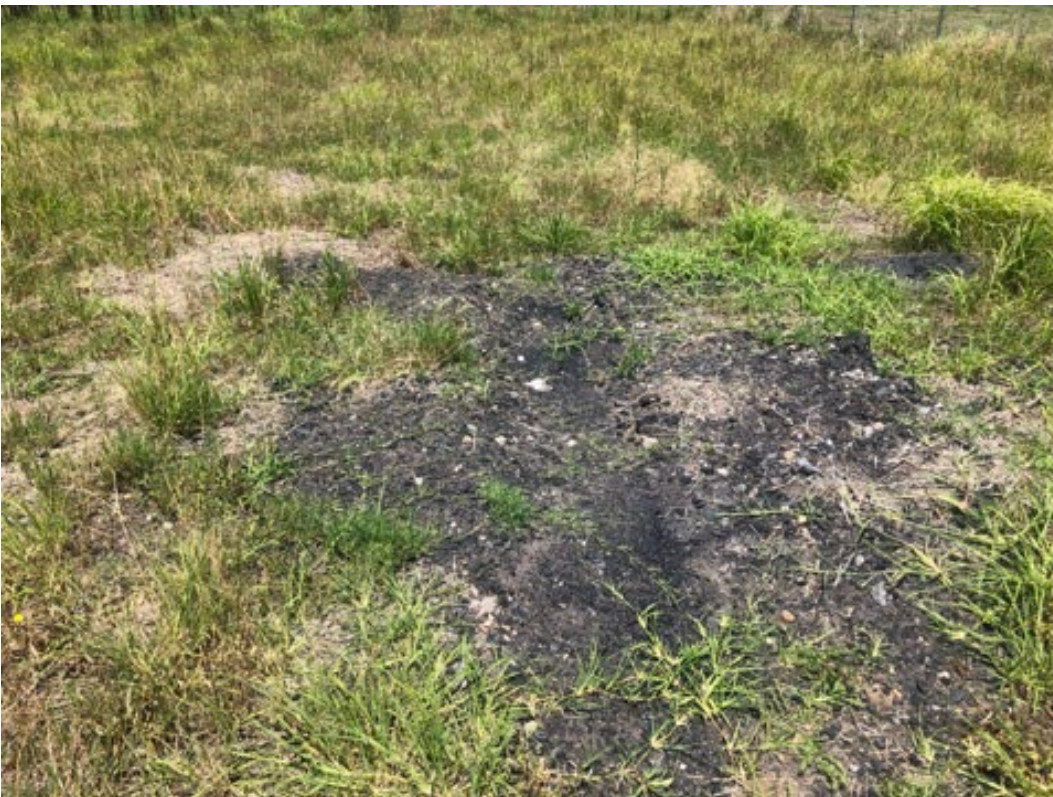
**Figure 6-2. Remnants of past geotechnical investigation**  
*Example of sub surface spoil in project area (depot, warehouse and carpark)*

The geotechnical data provides an indication that the landform across the Site has been completely modified. Two spoil piles from geotechnical studies are present within the proposed location for the depot area. In the wagons storage 4 minor spoil piles have been created due to unknown ground disturbances. The presence of these spoil piles and the knowledge that the entire landscape has had decades of coal deposition emphasises the destruction of the original landform.

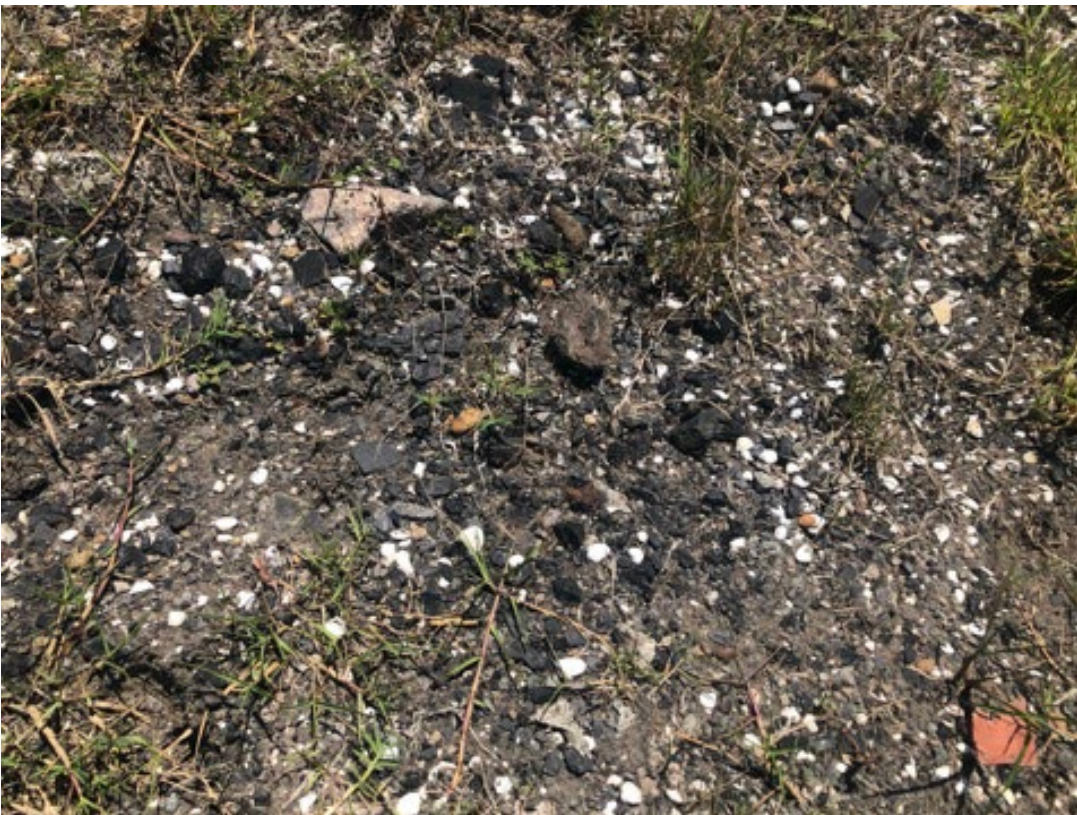
**Figure 6-4. Hole in ground with erosion**  
*Example of subsurface spoil in the project area (wagon storage)*

Mixed in within the coal refuse is the presence of whole and fragmented shell as can be seen in Figure 6-4 and is seen exclusively in the proposed wagon storage area. This material is understood to have been brought in with bedding sand dredged from the Swansea Channel as fill material. Also observed within the Site was the frequent occurrence of historical material such as metal nails of varying size where also present, often pressed into the earth. Alongside this, on the southern section of the Site two stormwater inlets exist to assist during times of flooding.

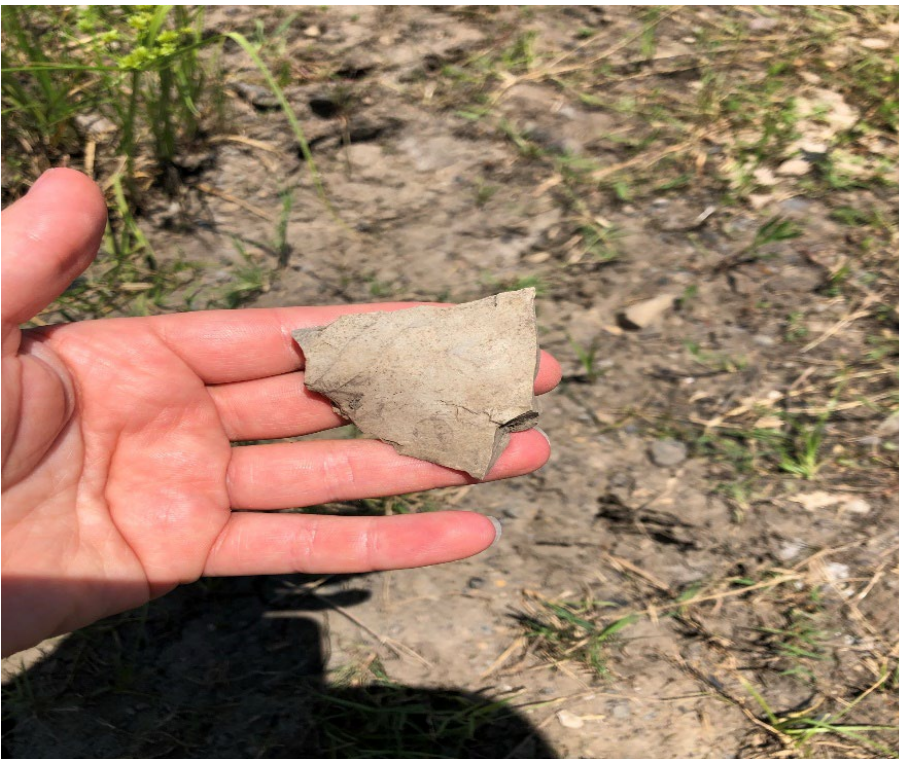
**Figure 6-6. Stone with potential flaking**  
*Raw material found in wagon storage area*

One stone with potential flaking was observed during the survey, of indeterminate material. No other examples of this type of material were identified in the Site. It is considered probably that this item was imported within spoil brought into the Site. Although the stone had potential flaking, closer inspection indicated that it had been fractured mechanically and further damaged during the spoil transportation. It is not considered to be cultural in origin and not classified as an Aboriginal object.

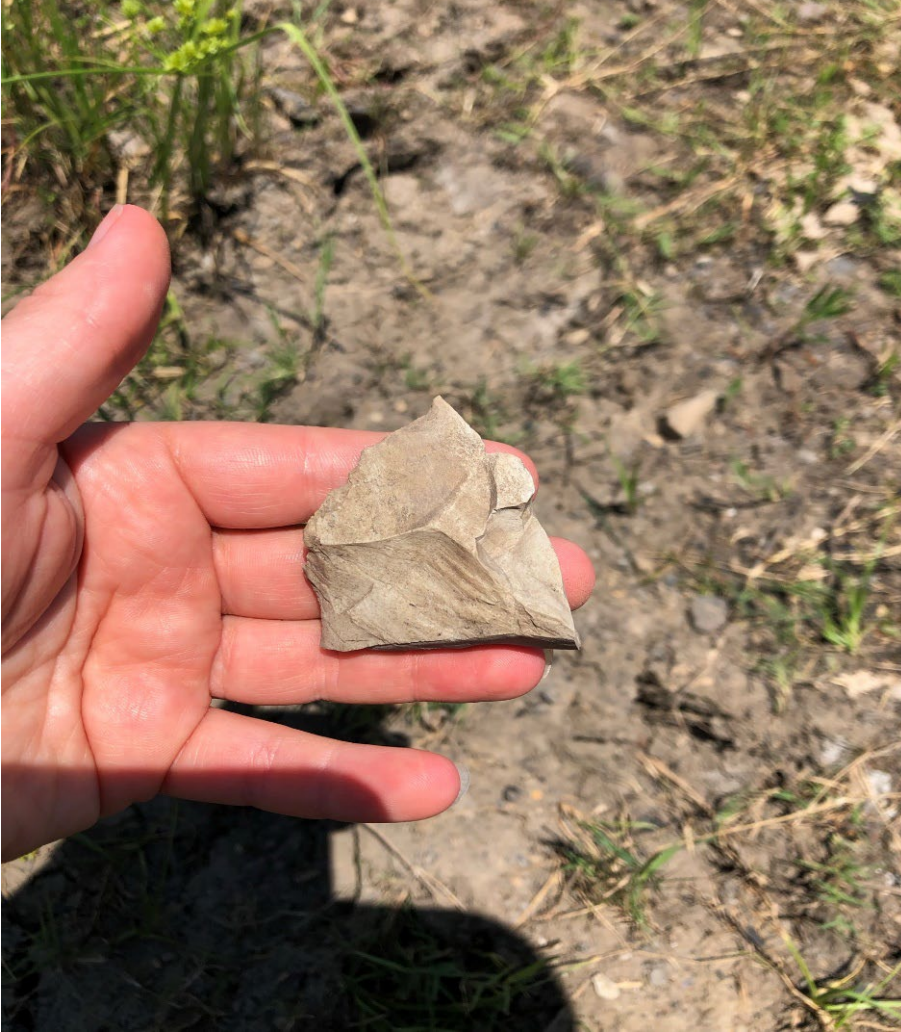
**Figure 6-7. Picture of stone with potential flaking**

*Raw material found in wagon storage area*

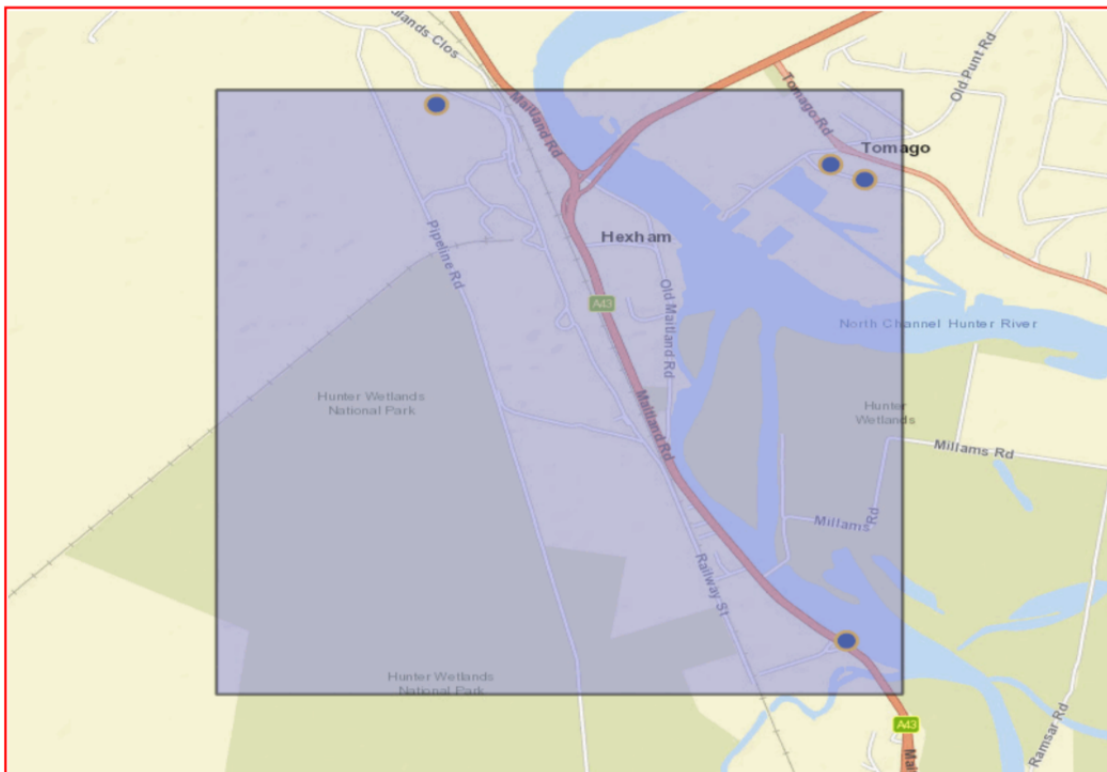
The context area of your search is shown in the map below. Please note that the map does not accurately display the exact boundaries of the search as defined in the paragraph above. The map is to be used for general reference purposes only.

**AHIMS Web Service search for the following area at Datum :GDA, Zone : 56, Eastings : 374767.0 - 378718.0, Northings : 6363982.0 - 6368054.0 with a Buffer of 0 meters, conducted by Alexandra Seifertova on 09 December 2021.**

A search of Heritage NSW AHIMS Web Services (Aboriginal Heritage Information Management System) has shown that:

<b>5</b>	<b>Aboriginal sites are recorded in or near the above location.</b>
<b>0</b>	<b>Aboriginal places have been declared in or near the above location. *</b>
