# Hexham Train Support Facility: Site Management Plan

2 February 2023

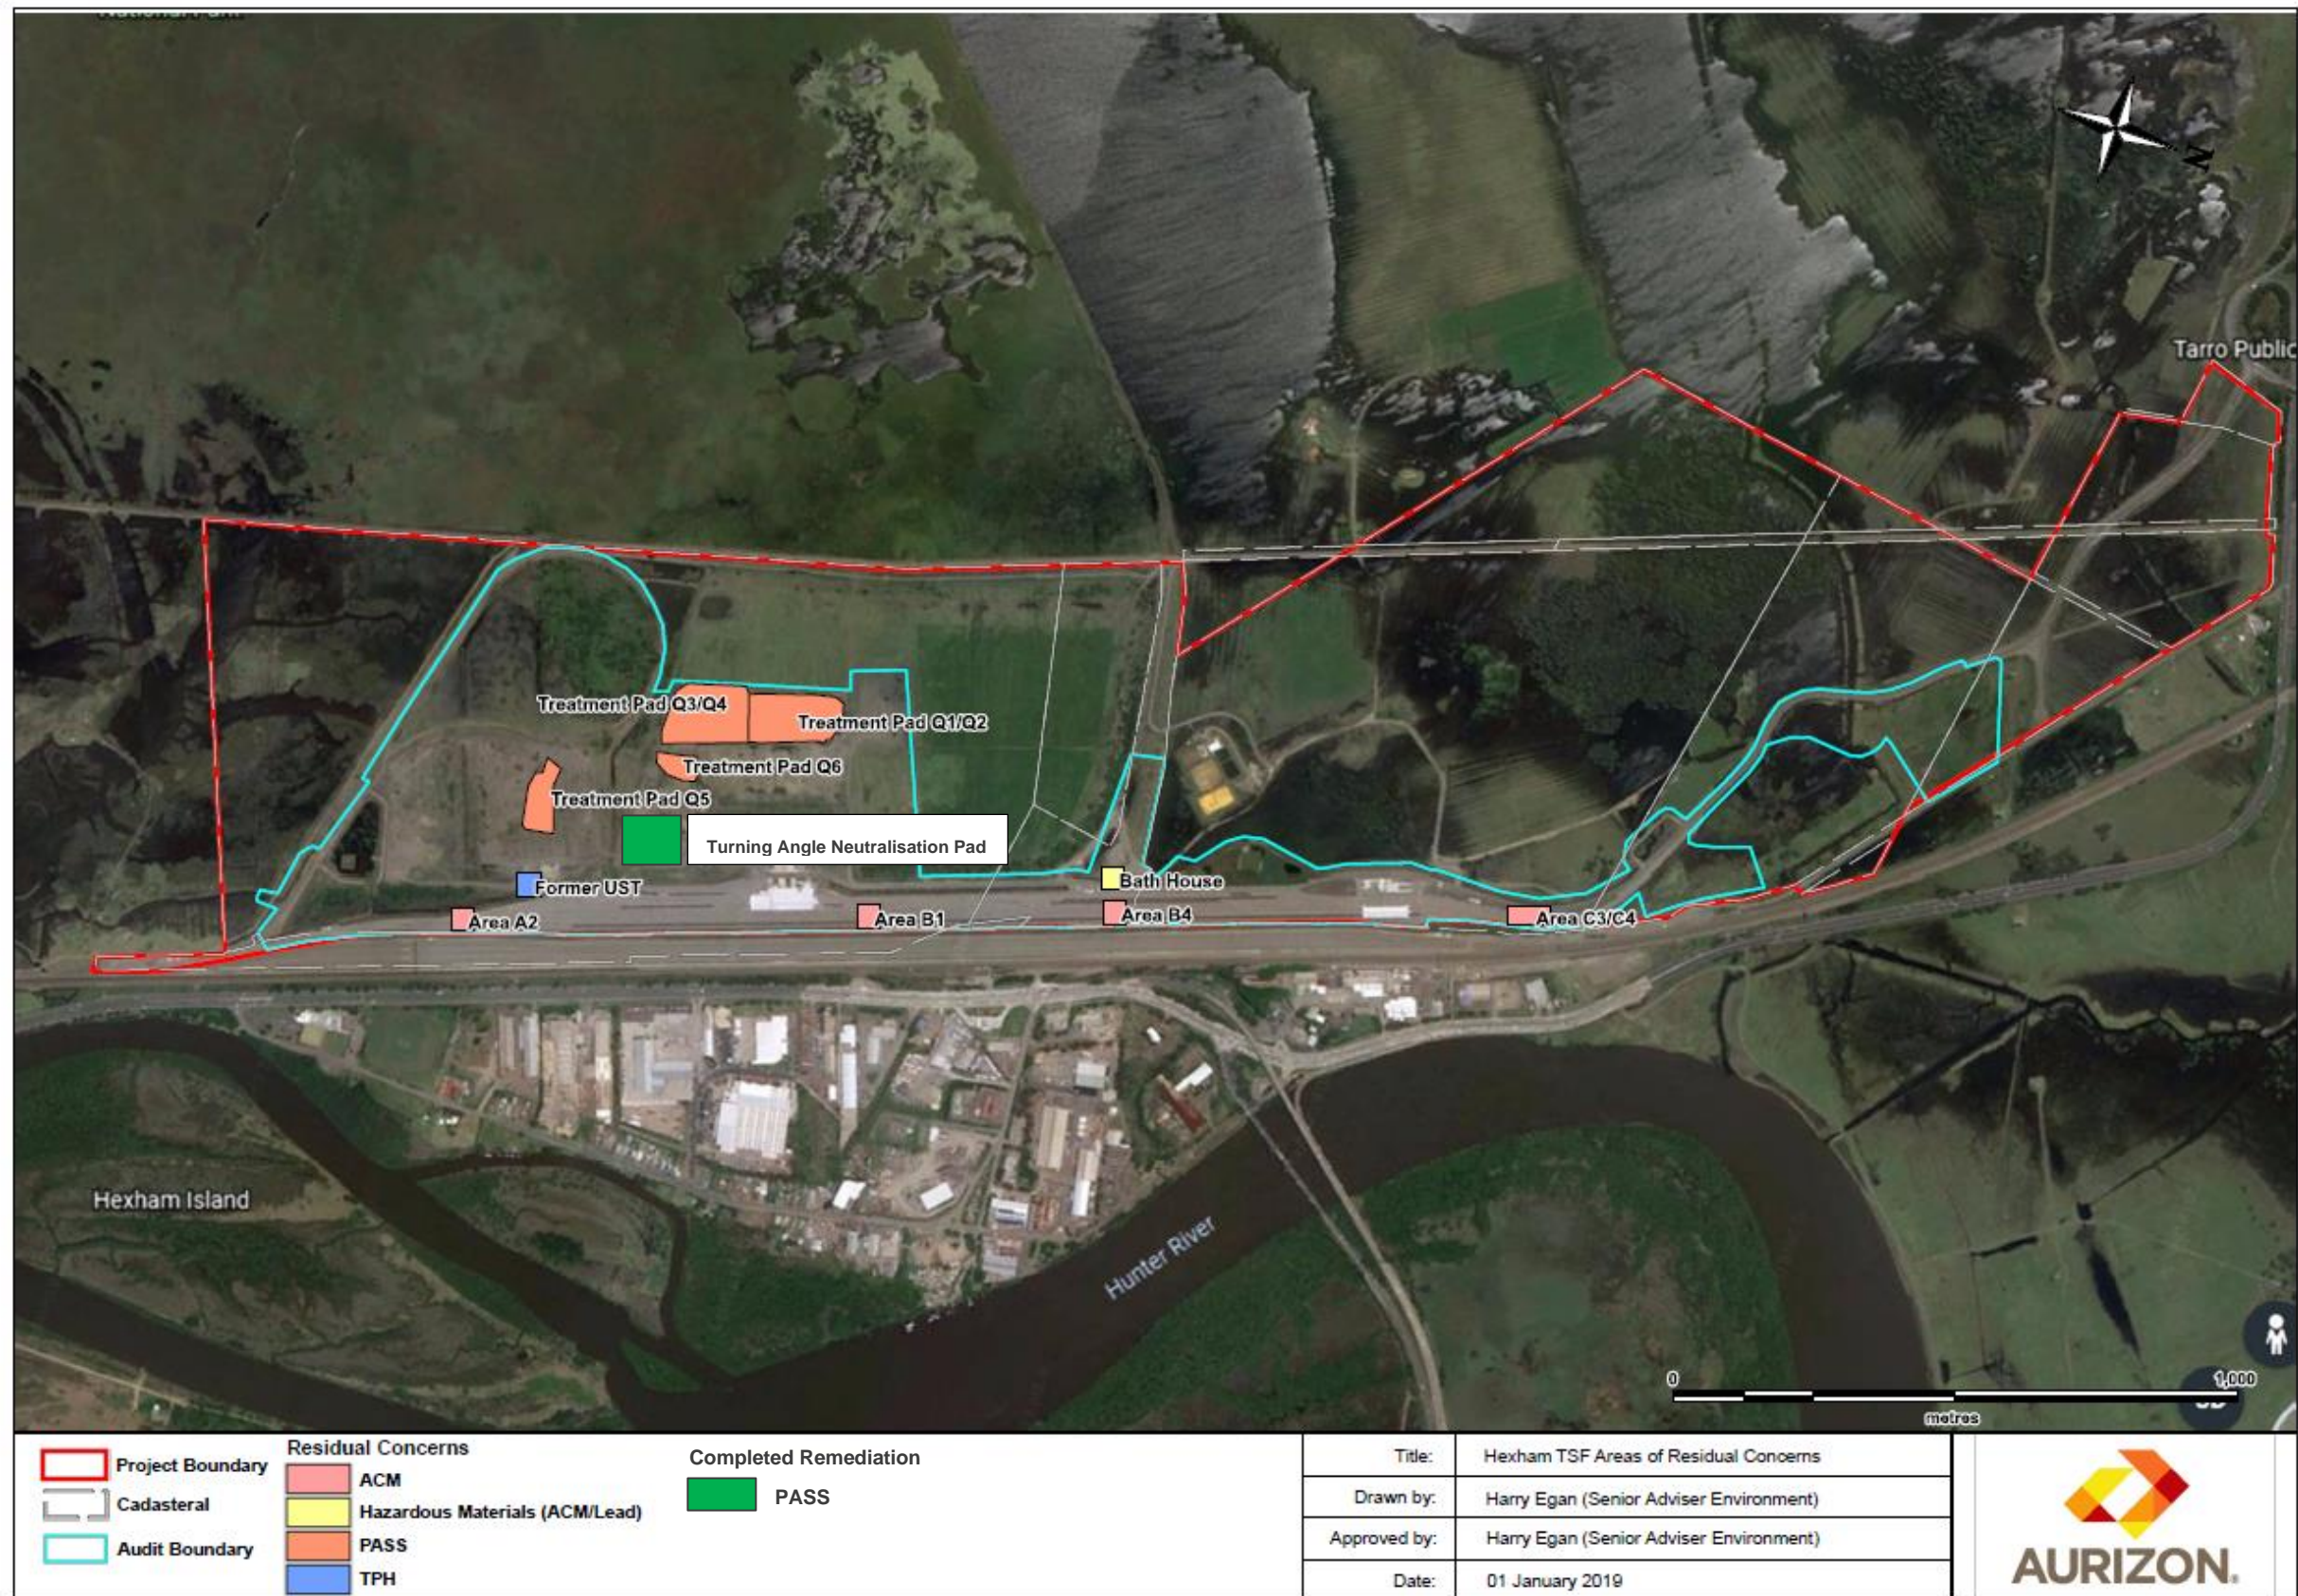
Figure 2 - Hexham TSF Areas of Residual Management

Completed remediation efforts, known residual management areas and their origin are discussed in Table 2. The location of known areas requiring residual management are shown in Figure 2.

As unidentified contamination is likely to exist elsewhere within the TSF project boundary from historical practices, such as underlying CWR or buried hazardous building materials dumped as fill, Figure 2 should be used as a guide only and will be updated as additional contamination is identified.

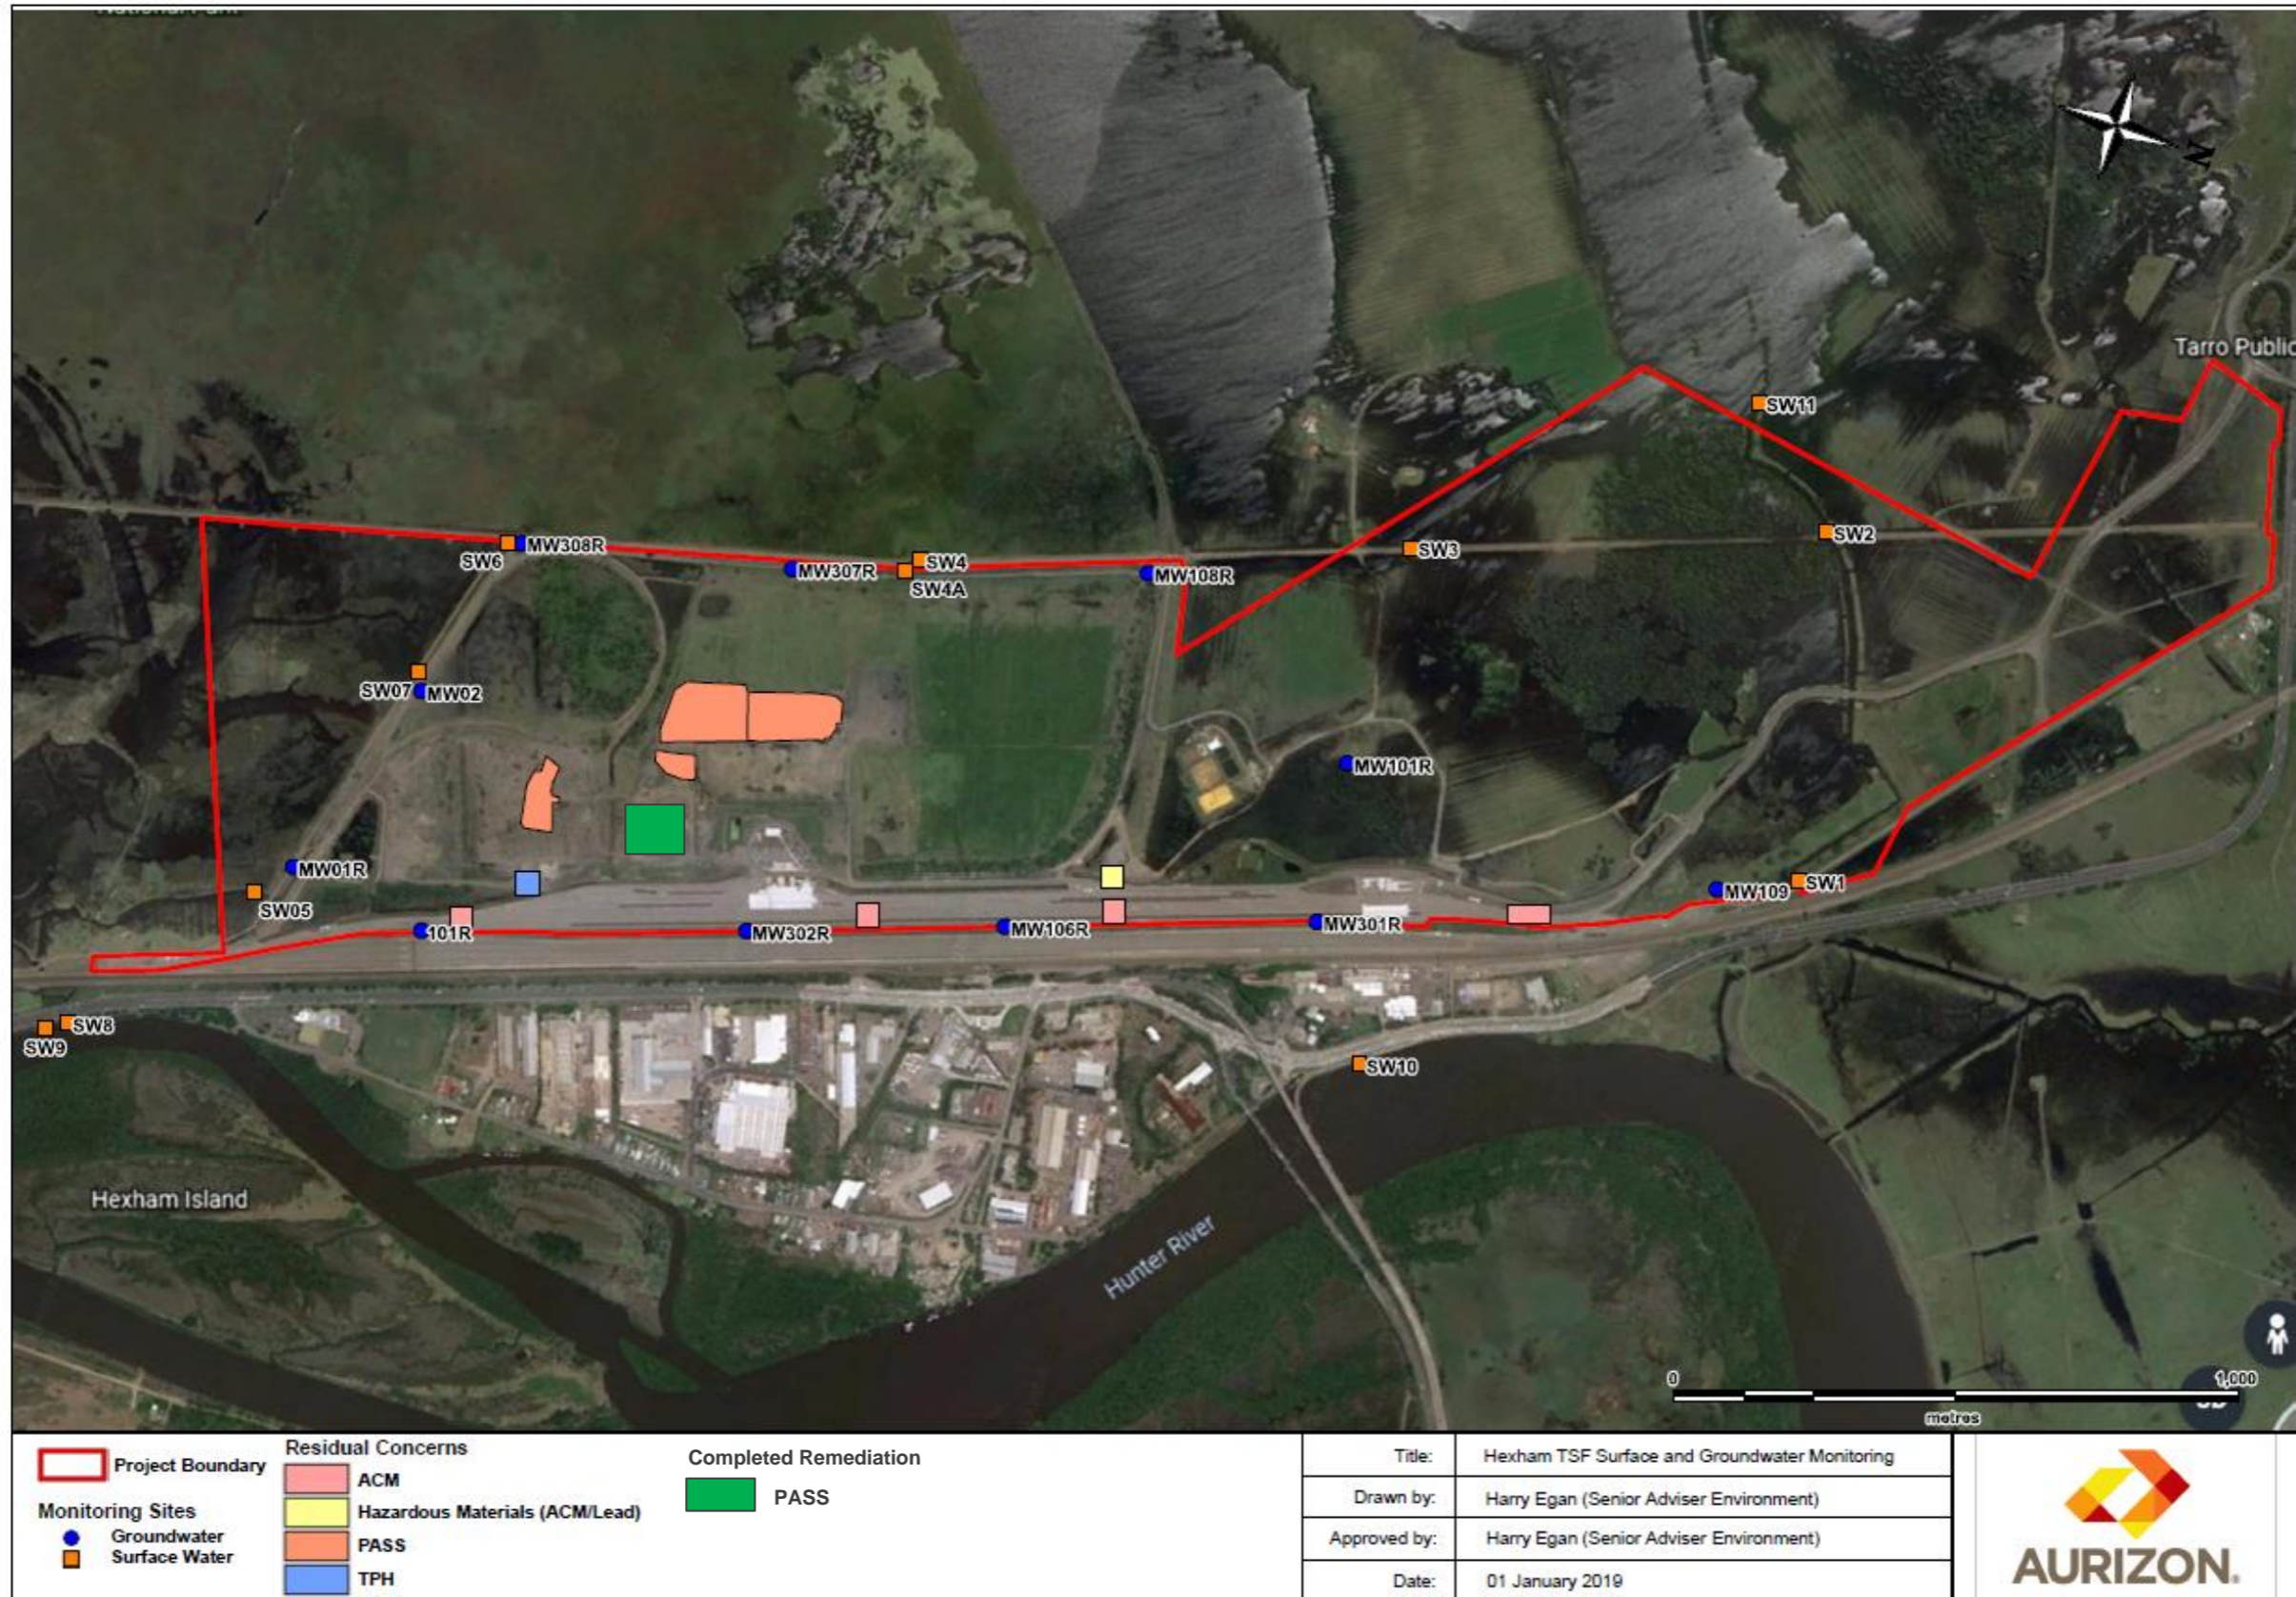
Figure 3 – Hexham TSF Environmental Monitoring Network

The placement of surface and groundwater monitoring locations is detailed in Table 3 and shown in Figure 3.

- Performance Criteria A – Hunter River (SW01, SW02 and SW03);
- Performance Criteria B – Hexham Swamp (SW04, SW05, SW06, SW07); and
- Performance Criteria C – (Groundwater).
