QR National

NSW Long Term Train Support Facility Remediation Action Plan

Revision 0
25 September 2012

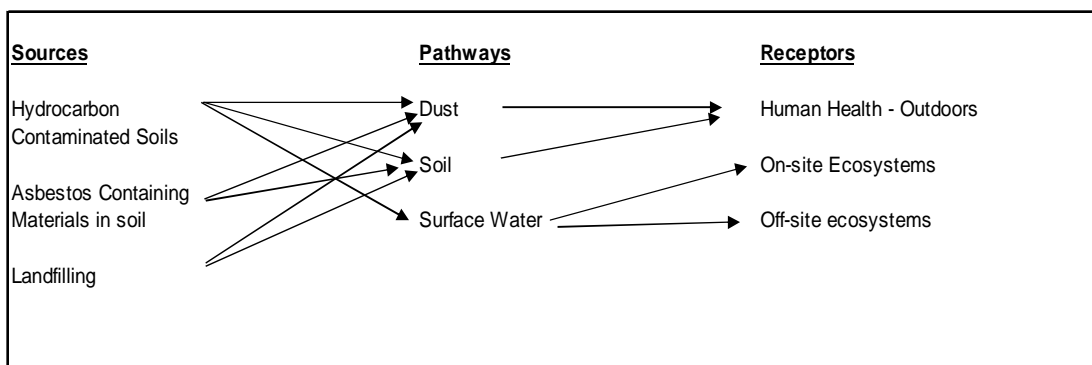
Source-Pathway-Receptor Linkages

A summary of the CSM is provided in the figure below. Based on the outcomes of the assessment, potentially significant 'source->pathway->receptor' linkages that are considered to require a remediation or site management response are shown below:

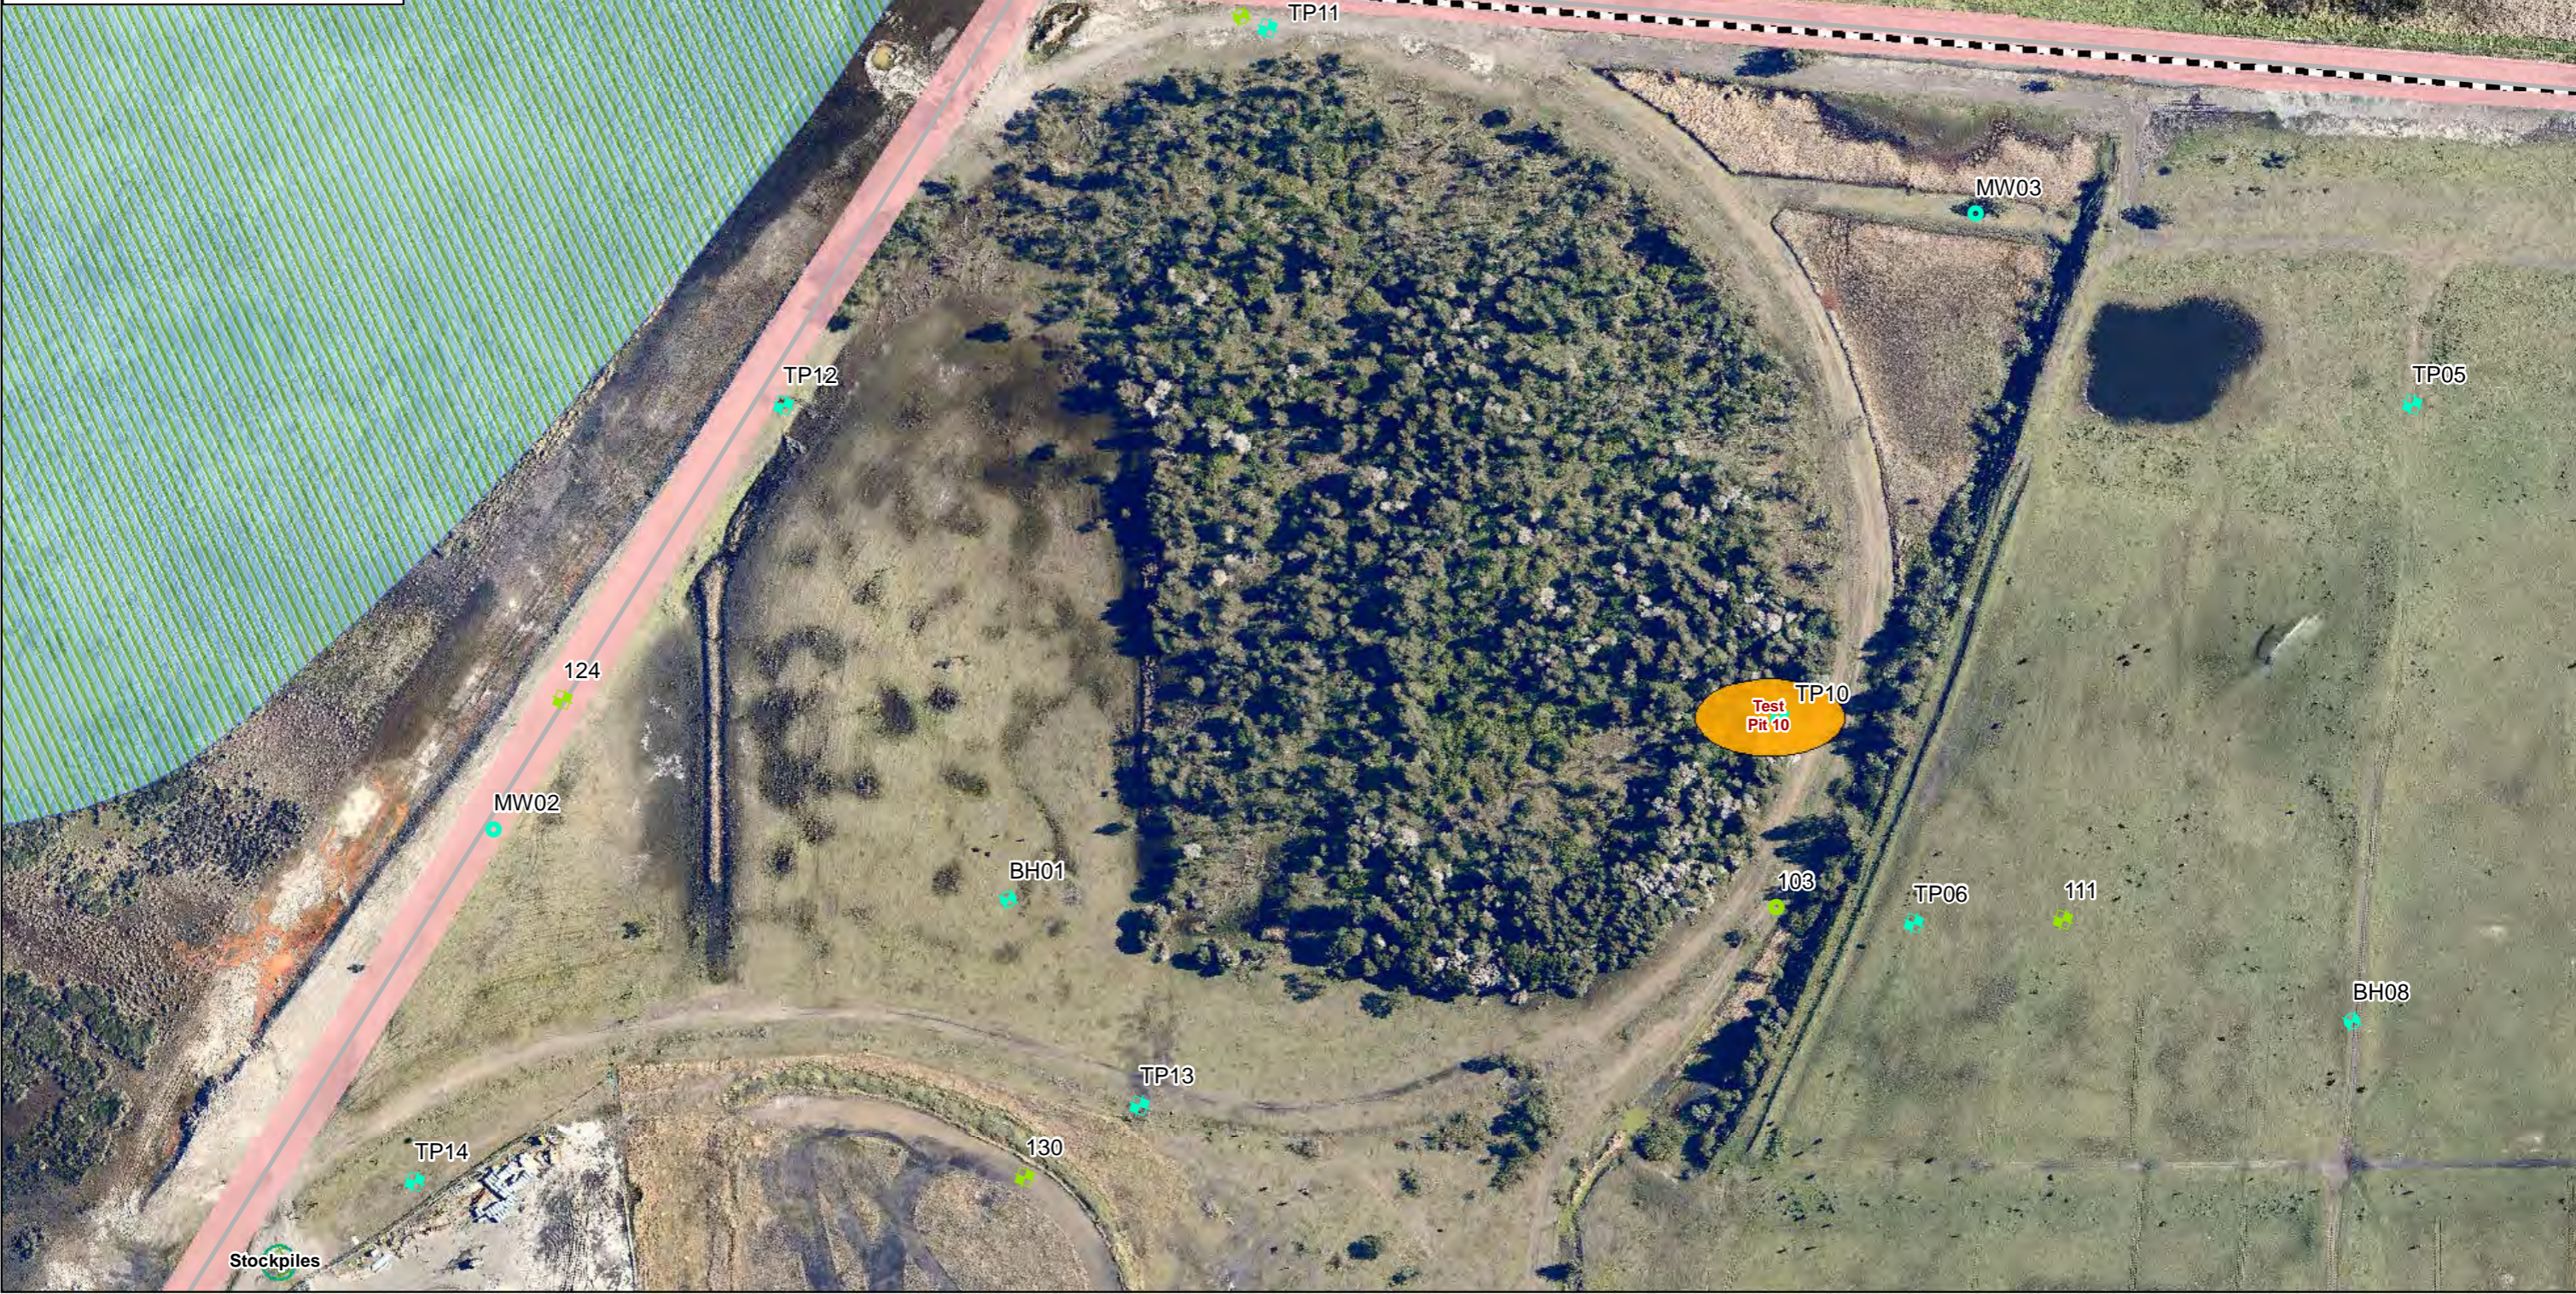
Note: Information on these drawings is based on specific sampling points and may not represent the conditions that may be encountered across the site at other than these locations. These drawings must be read in conjunction with the associated report including the limitations statement.

Previous Investigations		ERM (2002)		GHD-LongMac (2005)	
	Borehole		Borehole		Test Pit
	Hand Auger		Monitoring Well		Test Pit
	Monitoring Well		Rail Ballast		Test Pit
	Surface Sample		Test Pit		Test Pit
	Test Pit		Borehole		Test Pit
	Borehole		Monitoring Well

- The exceedances of TRH C10-C36 were found to be generally widespread across the Site, from surface to ~3.0 mbgl (generally associated with fill material comprising coal fines and coal reject). The detection of asbestos was associated with visible fragments present around a pile of dumped demolition waste near TP10 and derelict buildings located approximately 40 m north of BH04.

- The detections of TRH C10-C36 were found to be generally widespread across the Site, from surface to 1.2 mbgl (limit of investigation) (generally associated with fill material comprising coal fines and coal reject). The detections of PAH were predominantly associated with imported fill material used for the construction of Woodlands Close. The detection of asbestos was associated with visible fragments present on the soil surface generally associated with stockpiles of material (at location AS1, which was subsequently removed) or former buildings around the Coal Preparation Plant (around AS1 and AS2) (Figure D0002).
