Hexham Train Support Facility

Aurizon

Statement of Heritage Impact

8 March 2019

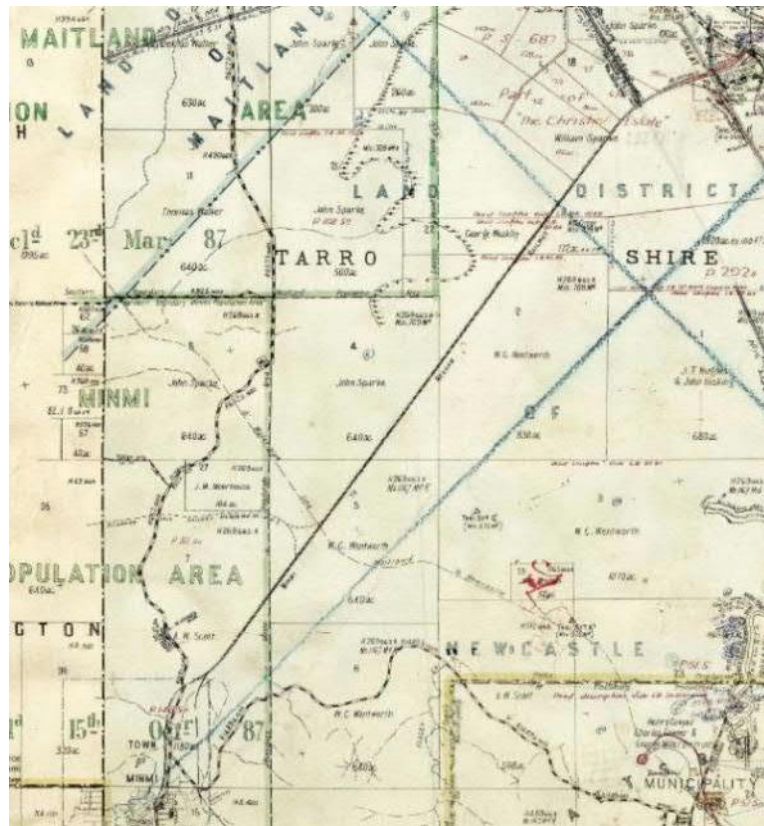
Figure 4.1: Minmi to Hexham Railway. Route can be seen as the diagonal line running in the centre of the map (Department of Lands 1917)

The railway's original route left the mine at Minmi and travelled northwards for half a mile before turning northeast for four miles, it crossed the swamplands to Hexham before turning east about half a mile before the Hunter River (refer to Figure 4.1). The railway was built predominantly on swampy ground and most of the tracks had to be built up with sand to elevate it. The railway was expanded in the early 20th century and was subsequently renamed as the Richmond Vale Railway. Figure 4.2 depicts an aerial photo from 1944 showing the northern section of the railway. The Minmi to Hexham Railway is located north of the study area and is listed on the *Newcastle Local Environmental Plan 2012*. It is viewed as having local heritage significance.

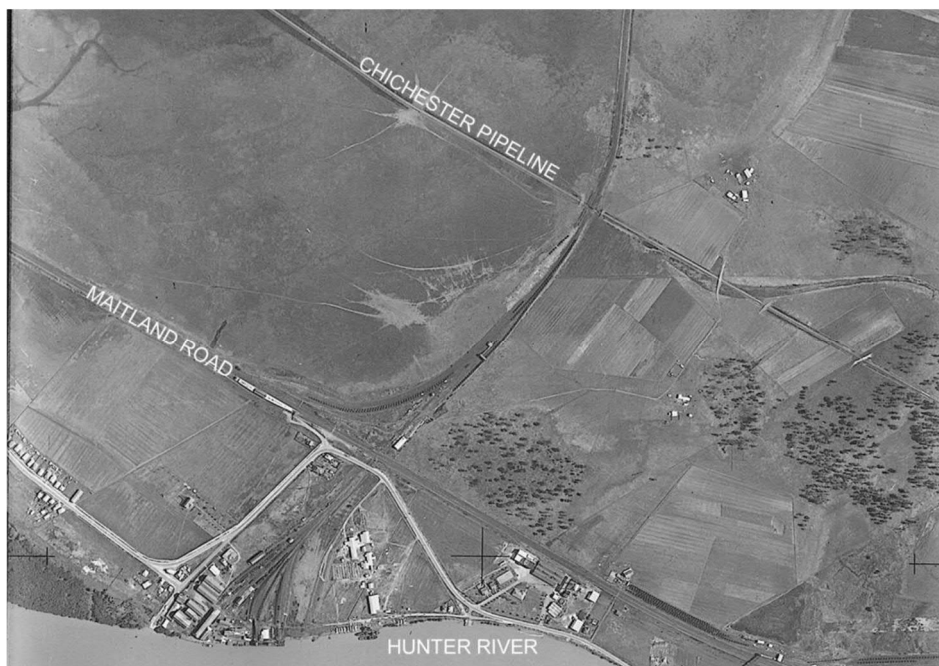
Figure 4.2: Aerial photo of part of the study area in 1944. The Minmi to Hexham Railway can be seen running in between the Chichester Pipeline and Maitland Road (NCC Plan Room as cited in EJE Heritage 2012, p. 26)

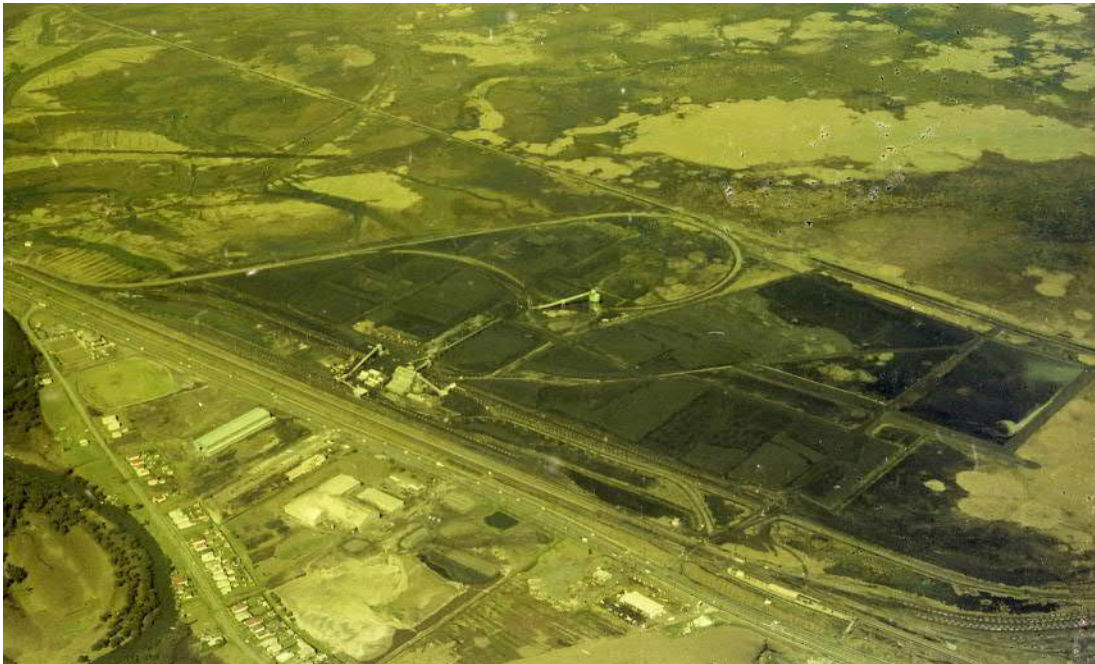
Figure 4.3: Aerial photo of the study area in 1975 which depicts the extent of coal production and shows the extent of the Balloon loop (Andrews 1975)

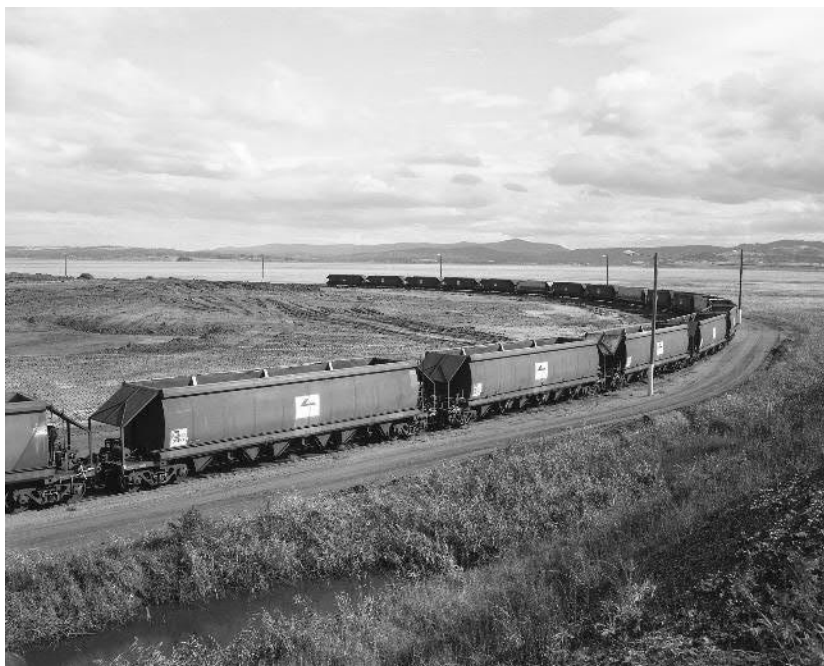
Figure 4.5: Train on Hexham balloon loop (Andrews 1988)

The washery reject was disposed on site in emplacements adjacent to the preparation plant. These emplacements were constructed horizontally, and the tailing were dewatered in tailings ponds. When the tailings ponds were filled and drained they were covered with coarse reject and the new platform was used as a temporary coal stockpile until an area was required for the next lift in the emplacement (Longworth & McKenzie Limited and Johnstone Environmental Technology Pty. Ltd 1987, p. 45). Figure 4.3 displays an aerial map of the area where large coal piles and the balloon loop can be seen. The balloon loop was constructed in 1973 to aid transferring coal from the Richmond Vale Railway to PTC trains (Engenicom Pty Ltd 2014, p. 11) (refer to Figures 4.4 and 4.5).

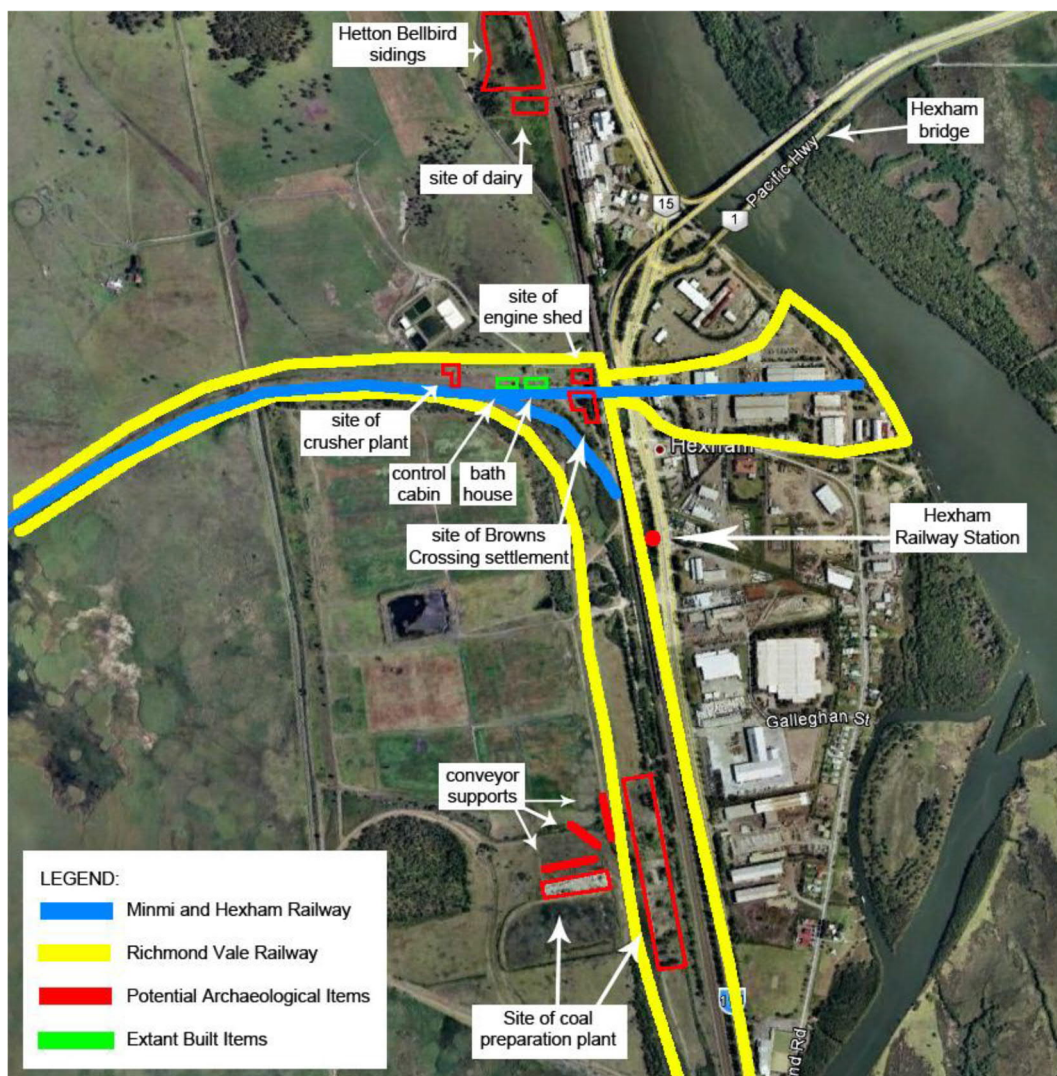
Figure 4.7: Heritage items identified within the Hexham TSF by EJE Heritage (Image reproduced from EJE Heritage 2012, p5).

The Coal Preparation Plant Footings and the Conveyor Belt Support Footings identified by EJE Heritage (2012) were identified in the CNIHMP as having no heritage significance and no mitigation measures were provided.

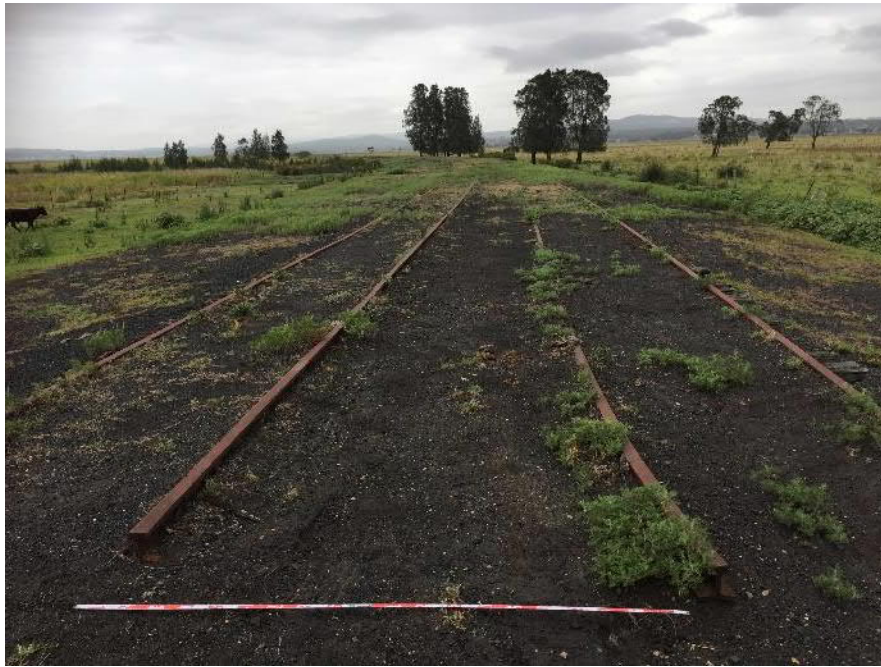
Figure 5.1: Minmi to Hexham Railway (located outside of the study area) (Source: Jacobs, 2019)

Firstly, the Minmi to Hexham Railway was visited. Lying outside the boundaries of the study area the railway is registered on the Newcastle LEP. The railway tracks lie approximately 1 km to the north of the study area and represent the early railway that was used to transport coal. The physical context of the railway (as can be viewed in Figure 5.1) has sparsely vegetated ground cover. Patches of erosion are present and most likely a result of the landscape being used as pastoral land. The erosion allows coal refuse to be visible on the surface. This coal is a result of the coal production and washery that was present on the site from the 1930's until 1967.

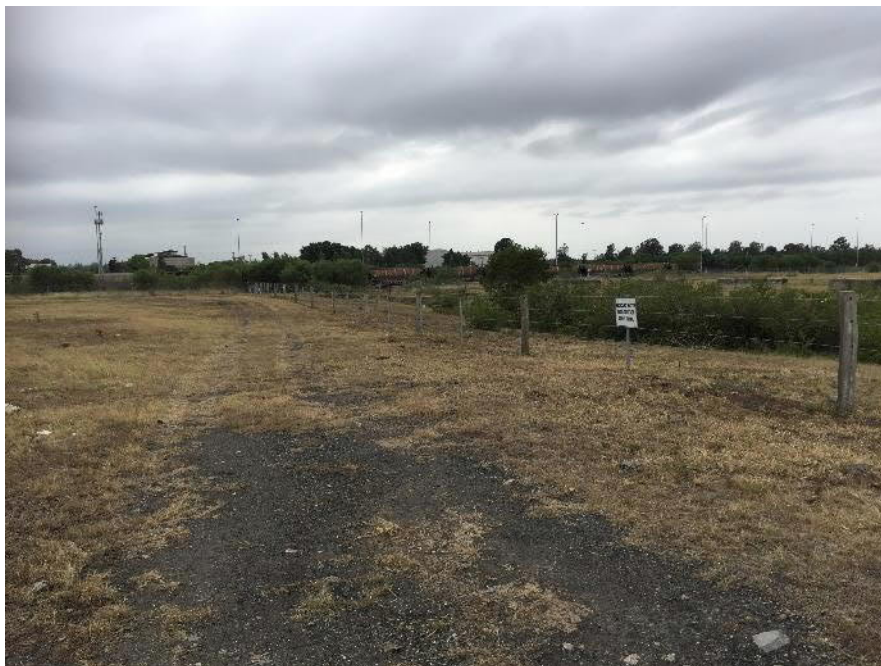
Figure 5.2: Study area with eroded section (Source: Jacobs, 2019)

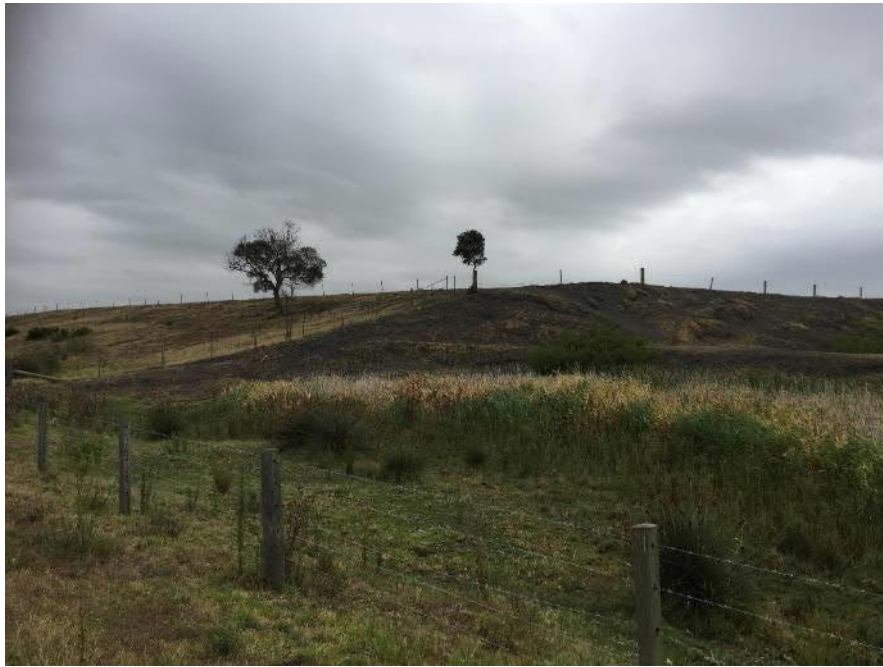
Figure 5.3: Coal tailings fill located near the study area boundary (Source: Jacobs, 2019)

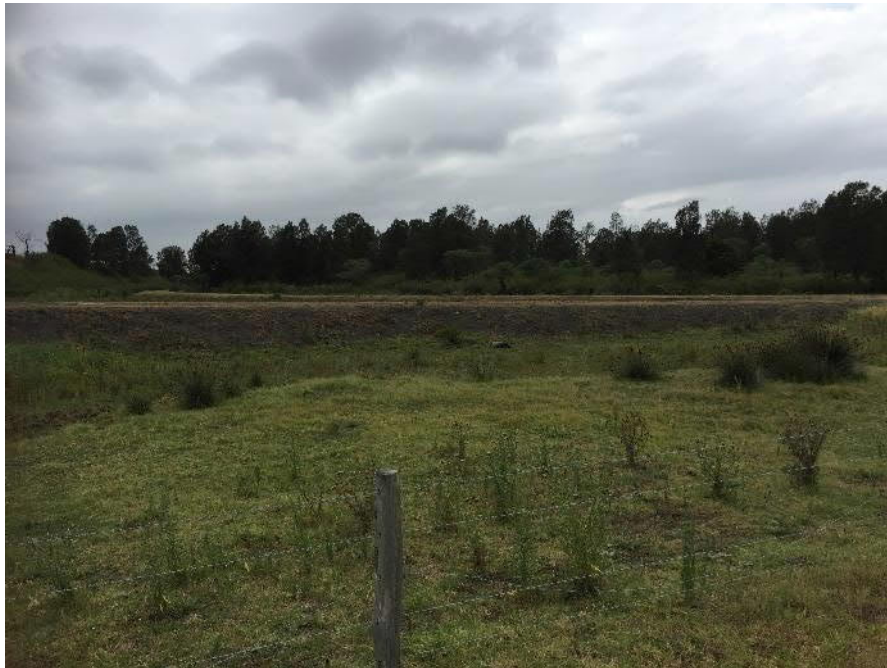
In addition to the presence of coal across the study area, the raised embankment established for the former Balloon Loop Siding was present in places (see Figure 5.4). The rail line associated with this siding, however, has been removed and no other in-situ remains of the balloon loop have survived.

Figure 5.4: Evidence of the raised embankment of the former Balloon loop siding (Source: Jacobs, 2019)

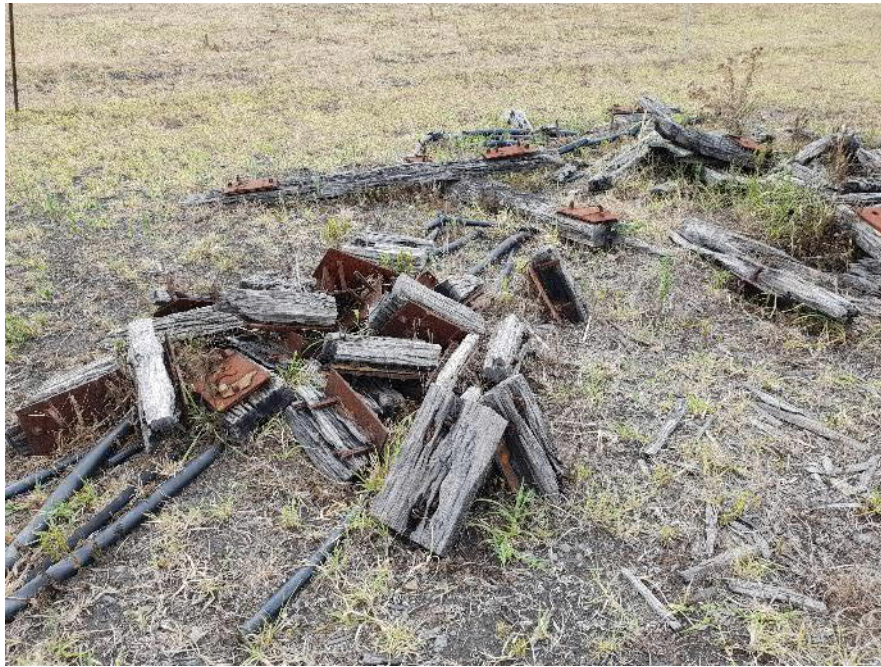
Within the study area some miscellaneous historical objects were located however they were not in-situ and do not provide any additional information about the history of the site. On the southern end of the study area a medium sized pile of timber and metal pieces was located (refer to Figure 5.5). These appear to be from the balloon loop located on the outside boundary of the study area. If from the balloon loop, these pieces date to post- 1973 and are not of local or State heritage significance. Furthermore, metal nails of varying size were also observed to be present. These nails were found within the timber pile and could be associated with the construction of railway tracks. Like the timber, however, these nails most likely date to post-1973 and as such do not hold historical significance.

Figure 5.5: Presence of timber and metal pieces within the study area (Source: Jacobs, 2019)

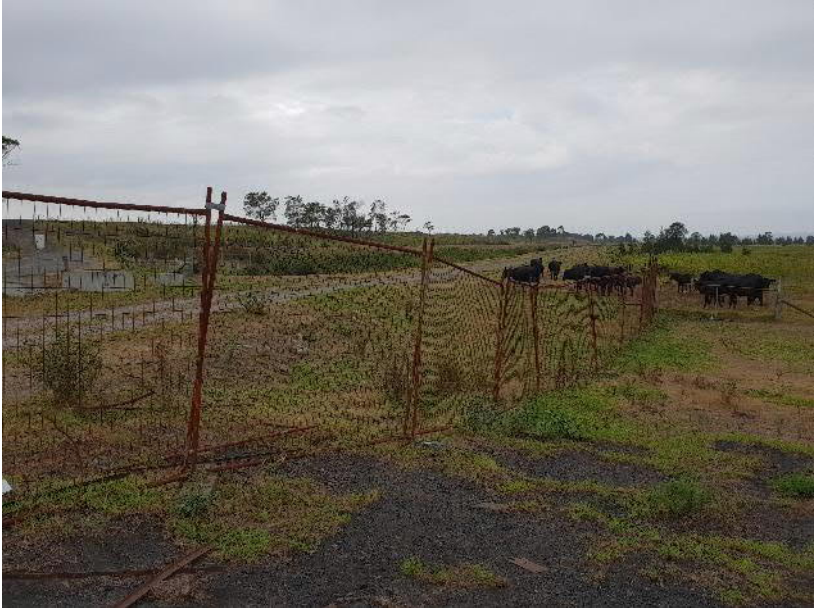
Legend for Figure 9.1	Description	Photo
A	Hexham rail line which is outside the study area. Access to the rail line is front an access road which is enclosed by wiring as well as an incomplete fence (as pictured).

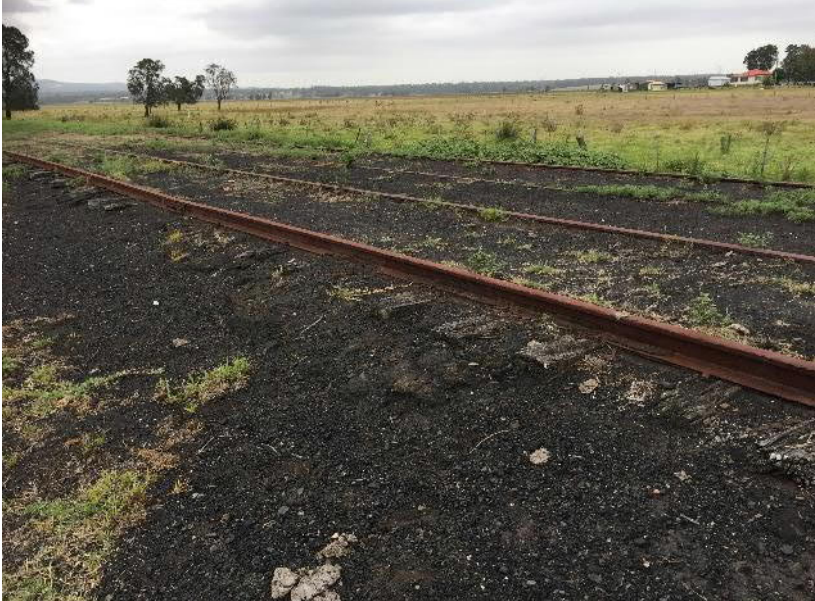
B	Hexham rail line which is outside the study area. Original wooden beams still in place. Large amount of erosion displaying layer of coal refuse.

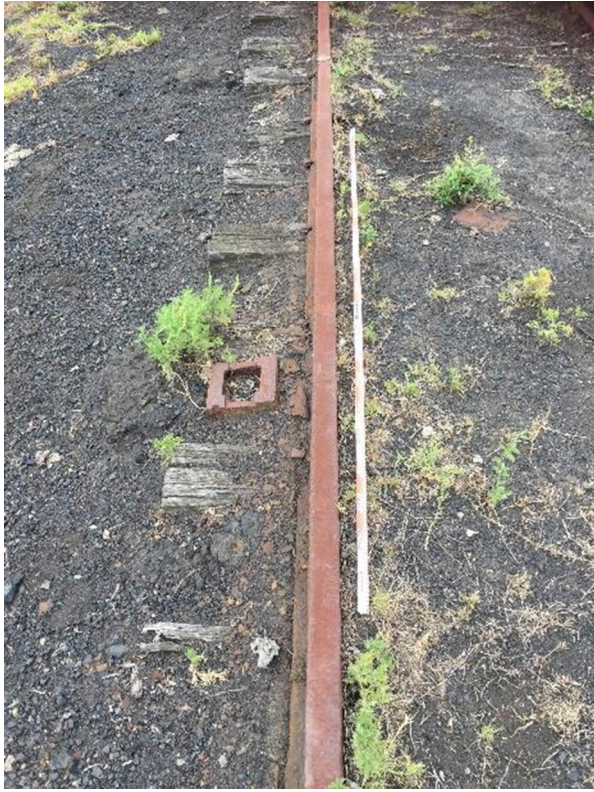
Legend for Figure 9.1	Description	Photo
C	<p>Detail of Hexham rail line (outside of the study area), with scale. This lies to the north of the study area.</p>

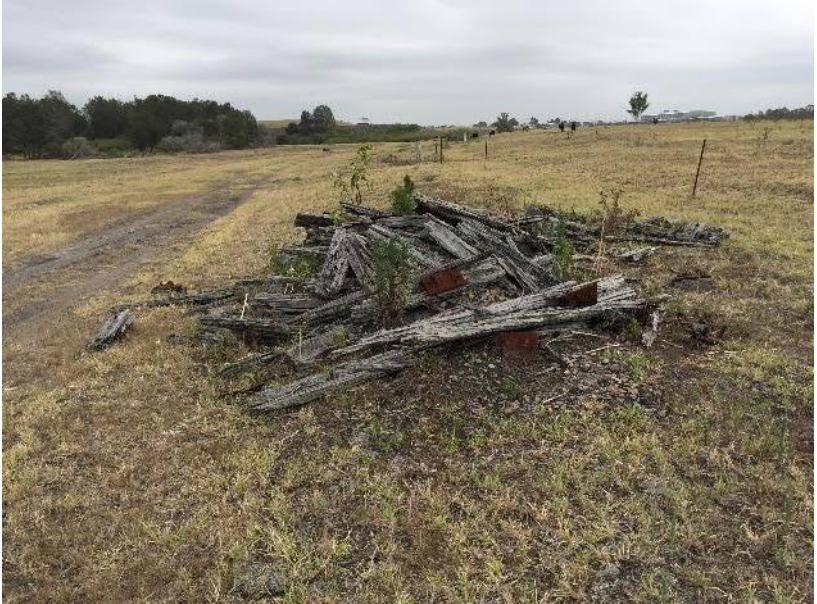
D	<p>Presence of timber and metal pieces within the study area. Appears to be part of the balloon loop located on the outside boundary.</p>

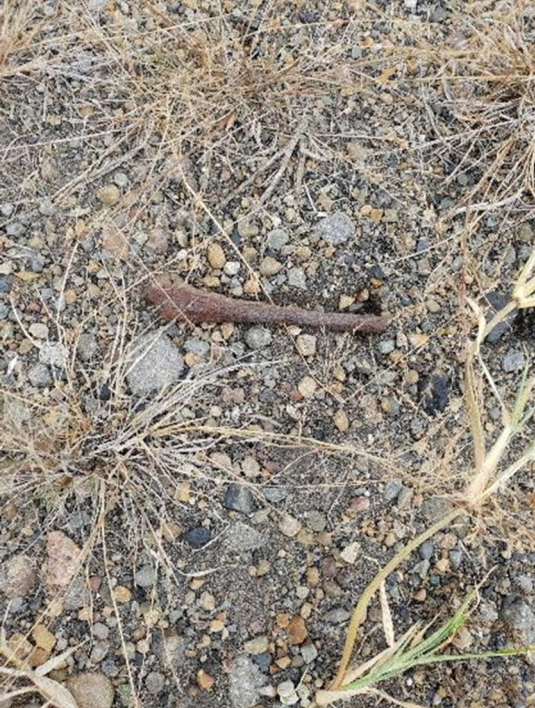
Legend for Figure 9.1	Description	Photo
E	Presence of miscellaneous nails throughout study area.

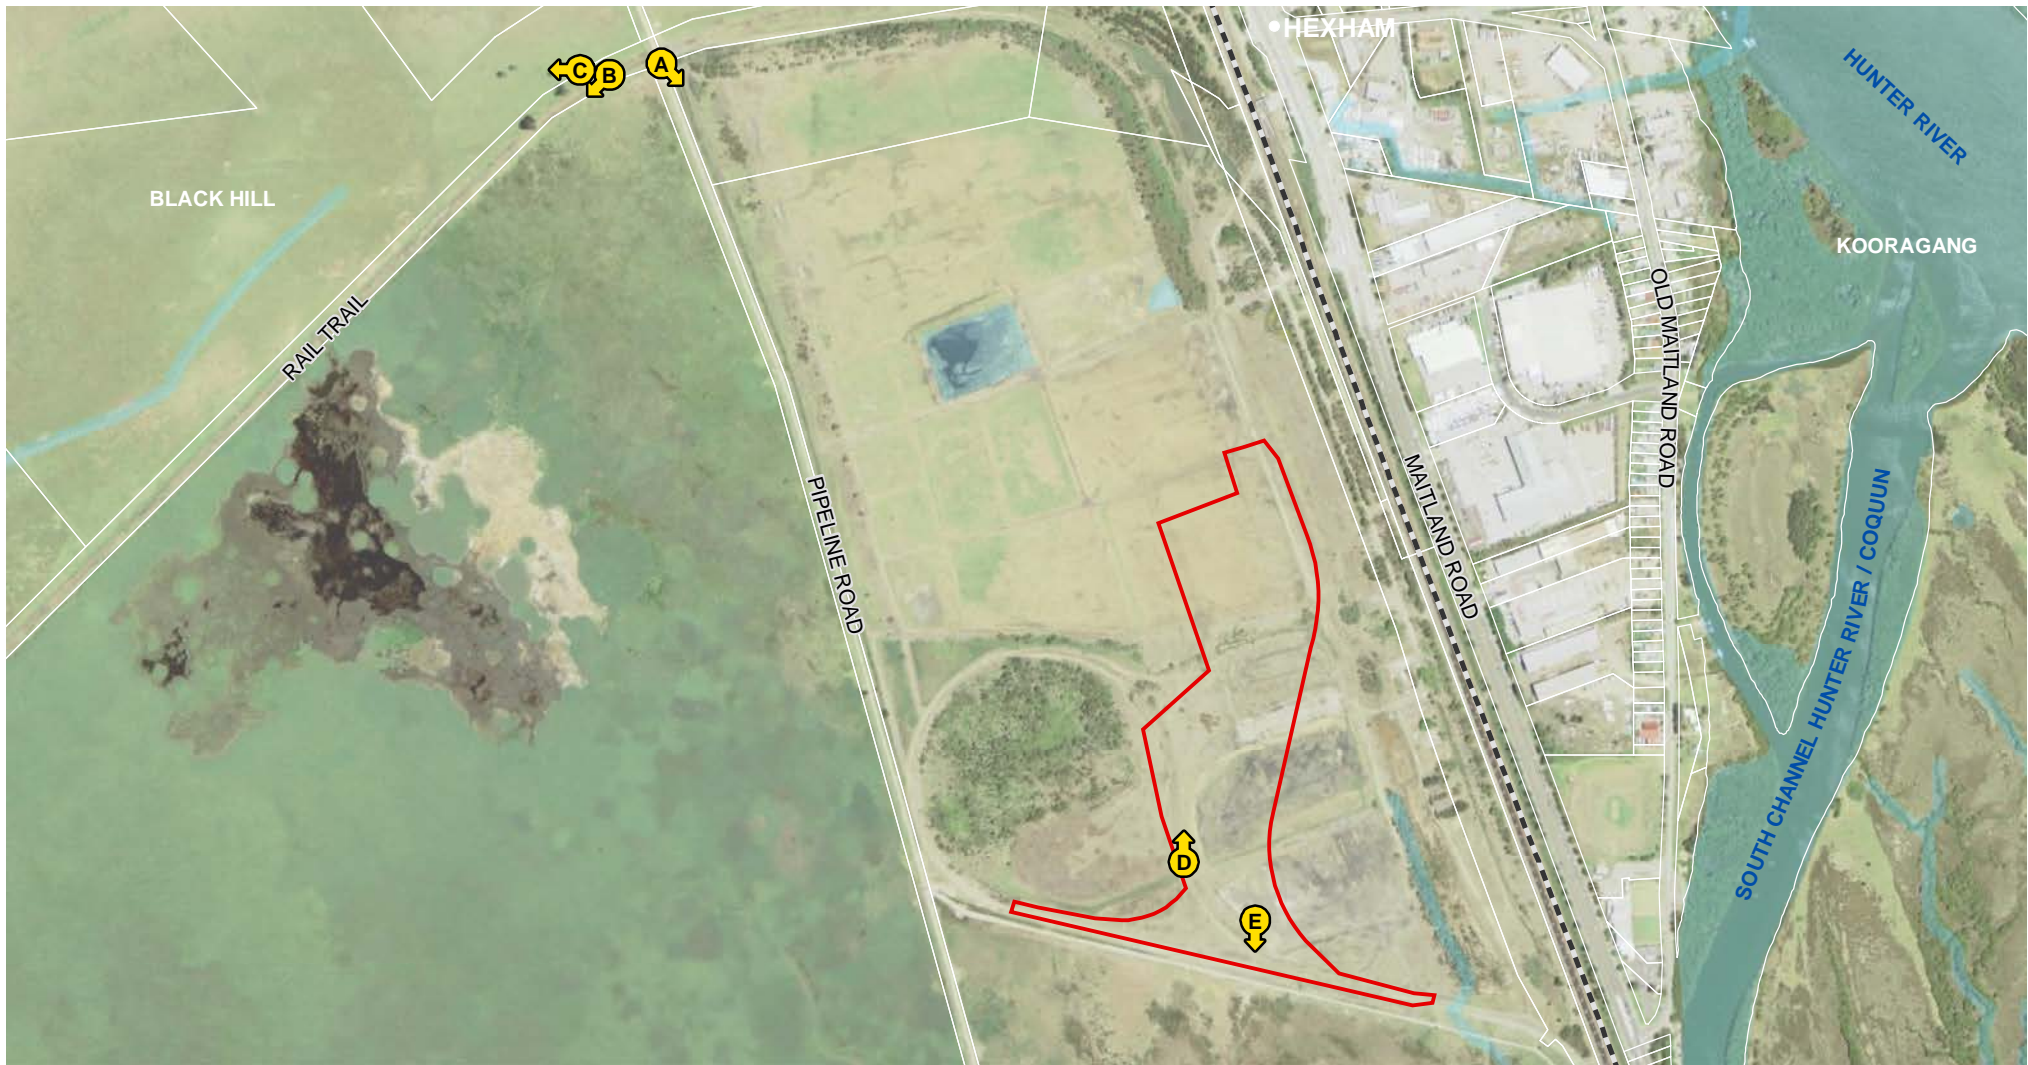
Figure 9.1 Map showing location of photos in Appendix A
