Hexham TSF Flood Emergency Management Plan

8 August 2024

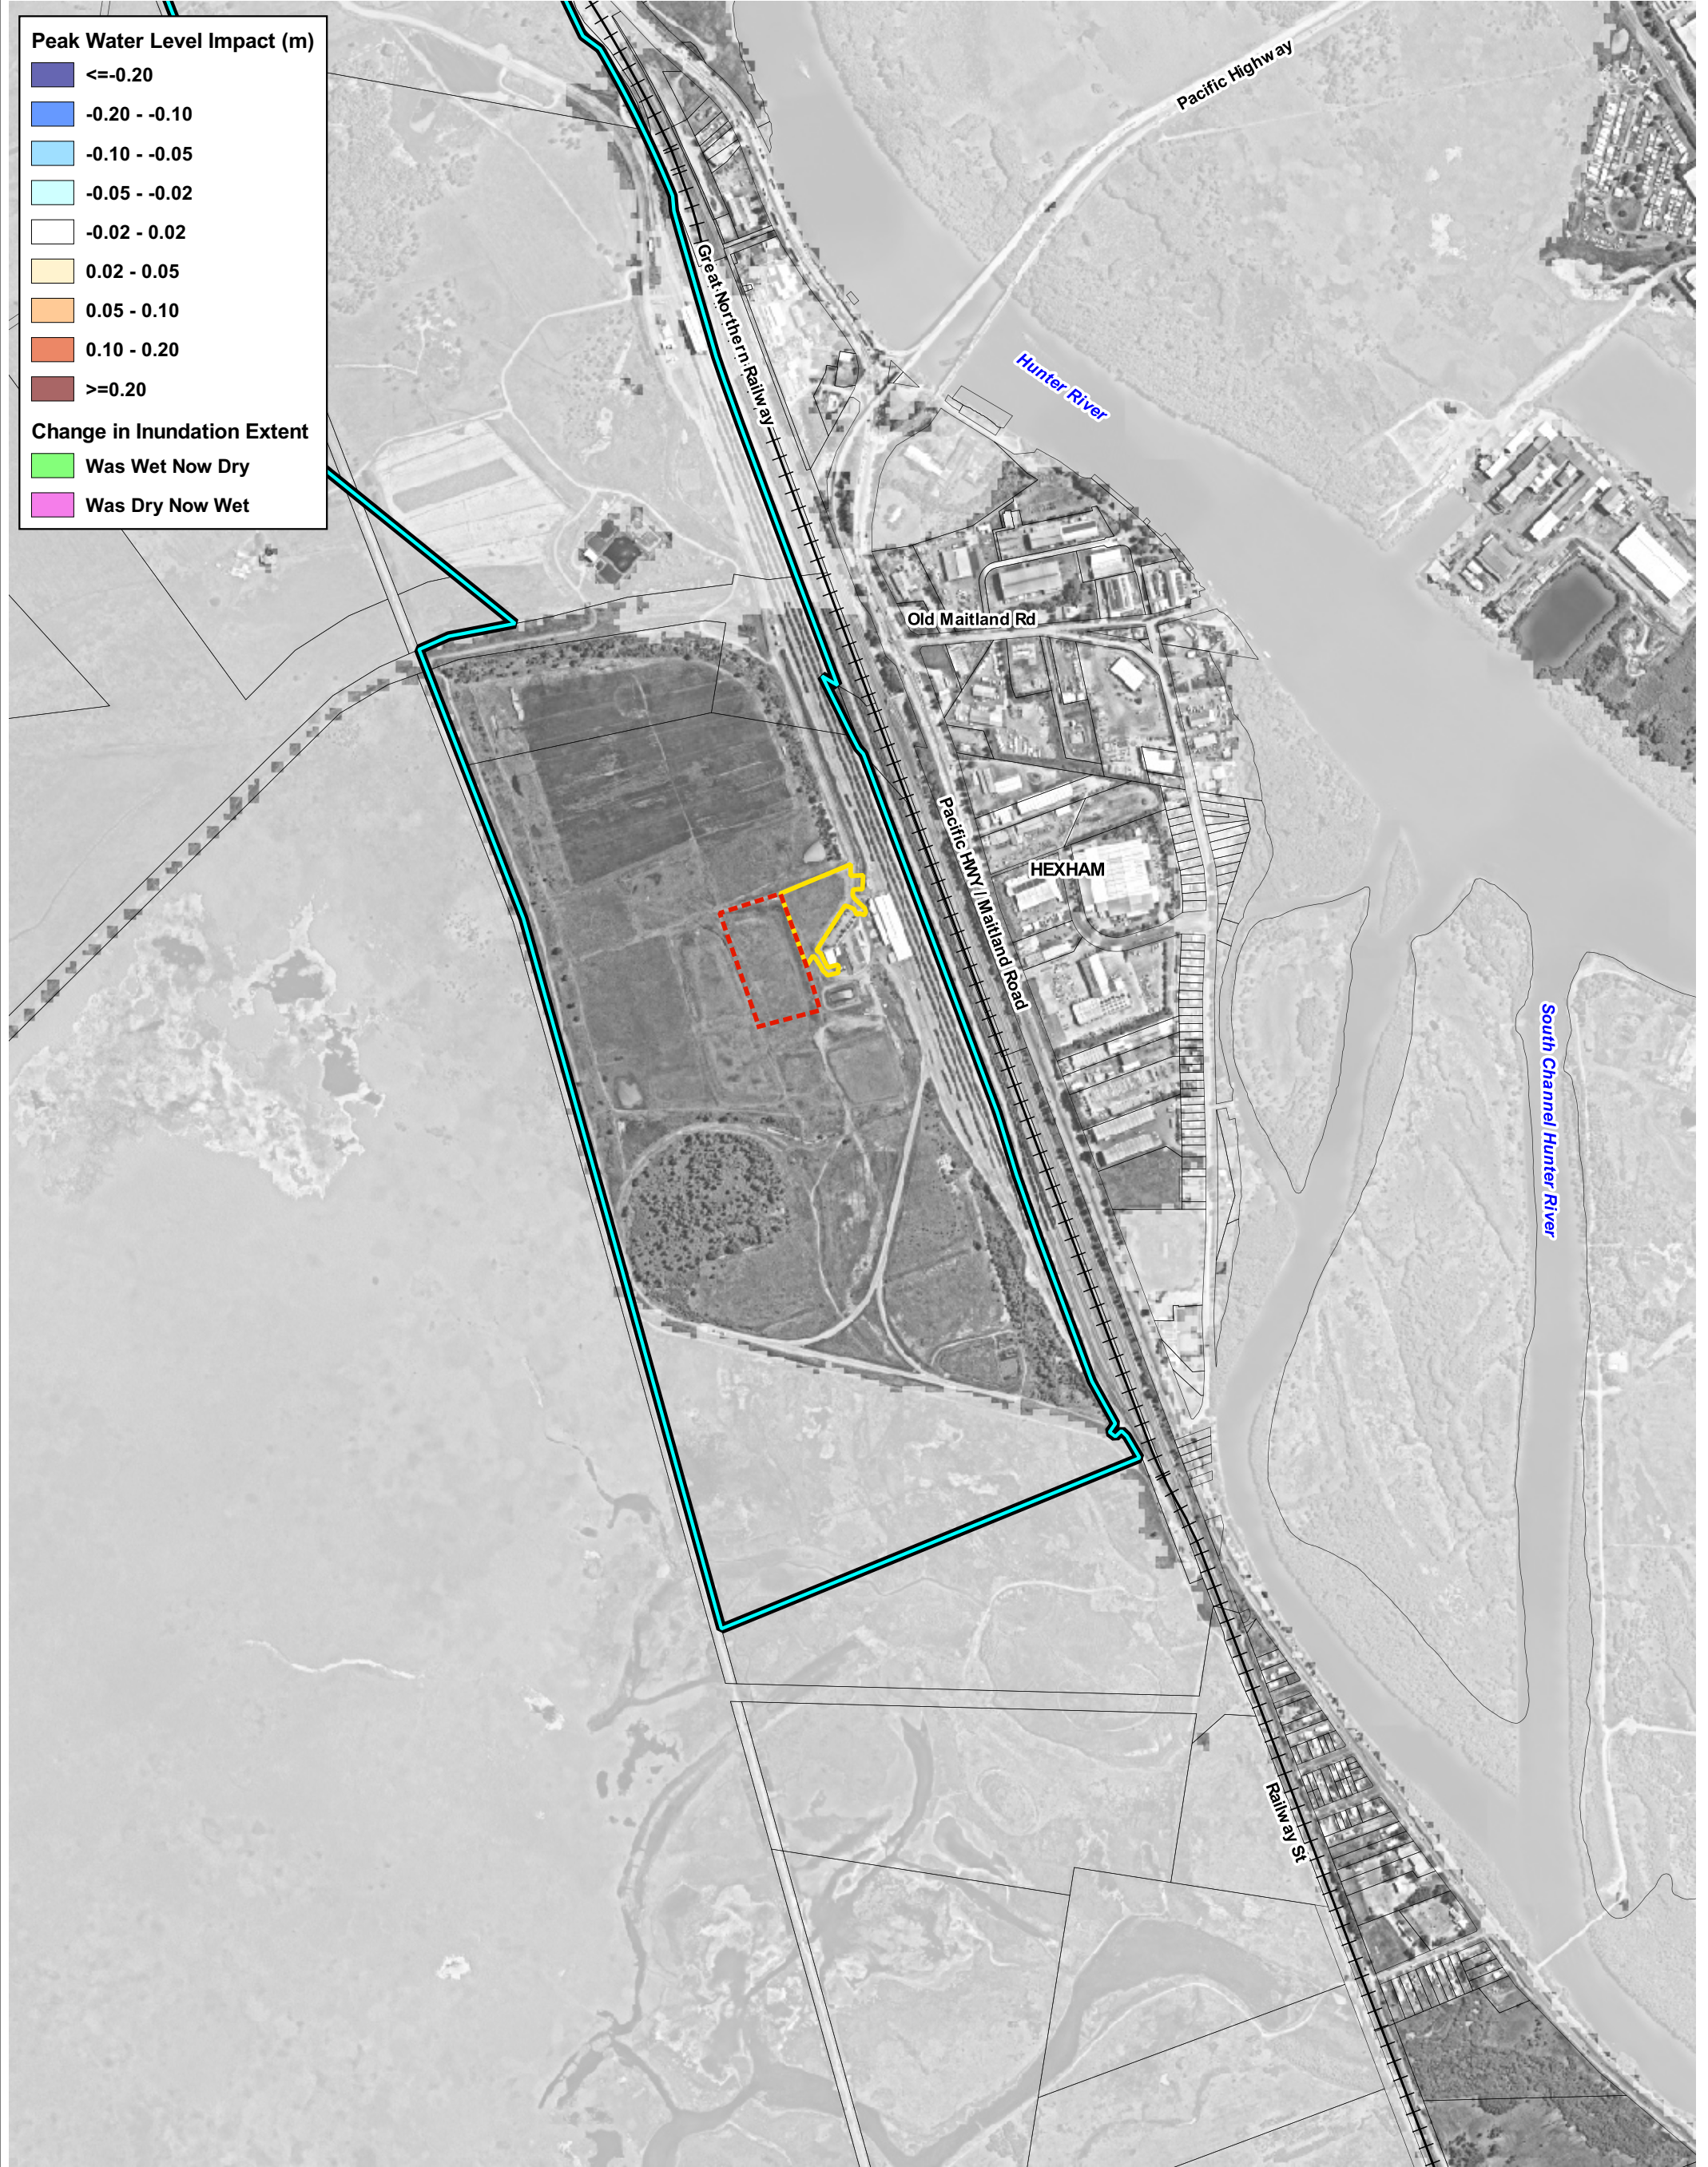
APPENDIX B – Flood Inundation Areas

Peak Water Level Impact (m)

- ≤ -0.20
- 0.20 - -0.10
- 0.10 - -0.05
- 0.05 - -0.02
- 0.02 - 0.02
- 0.02 - 0.05
- 0.05 - 0.10
- 0.10 - 0.20
- ≥ 0.20

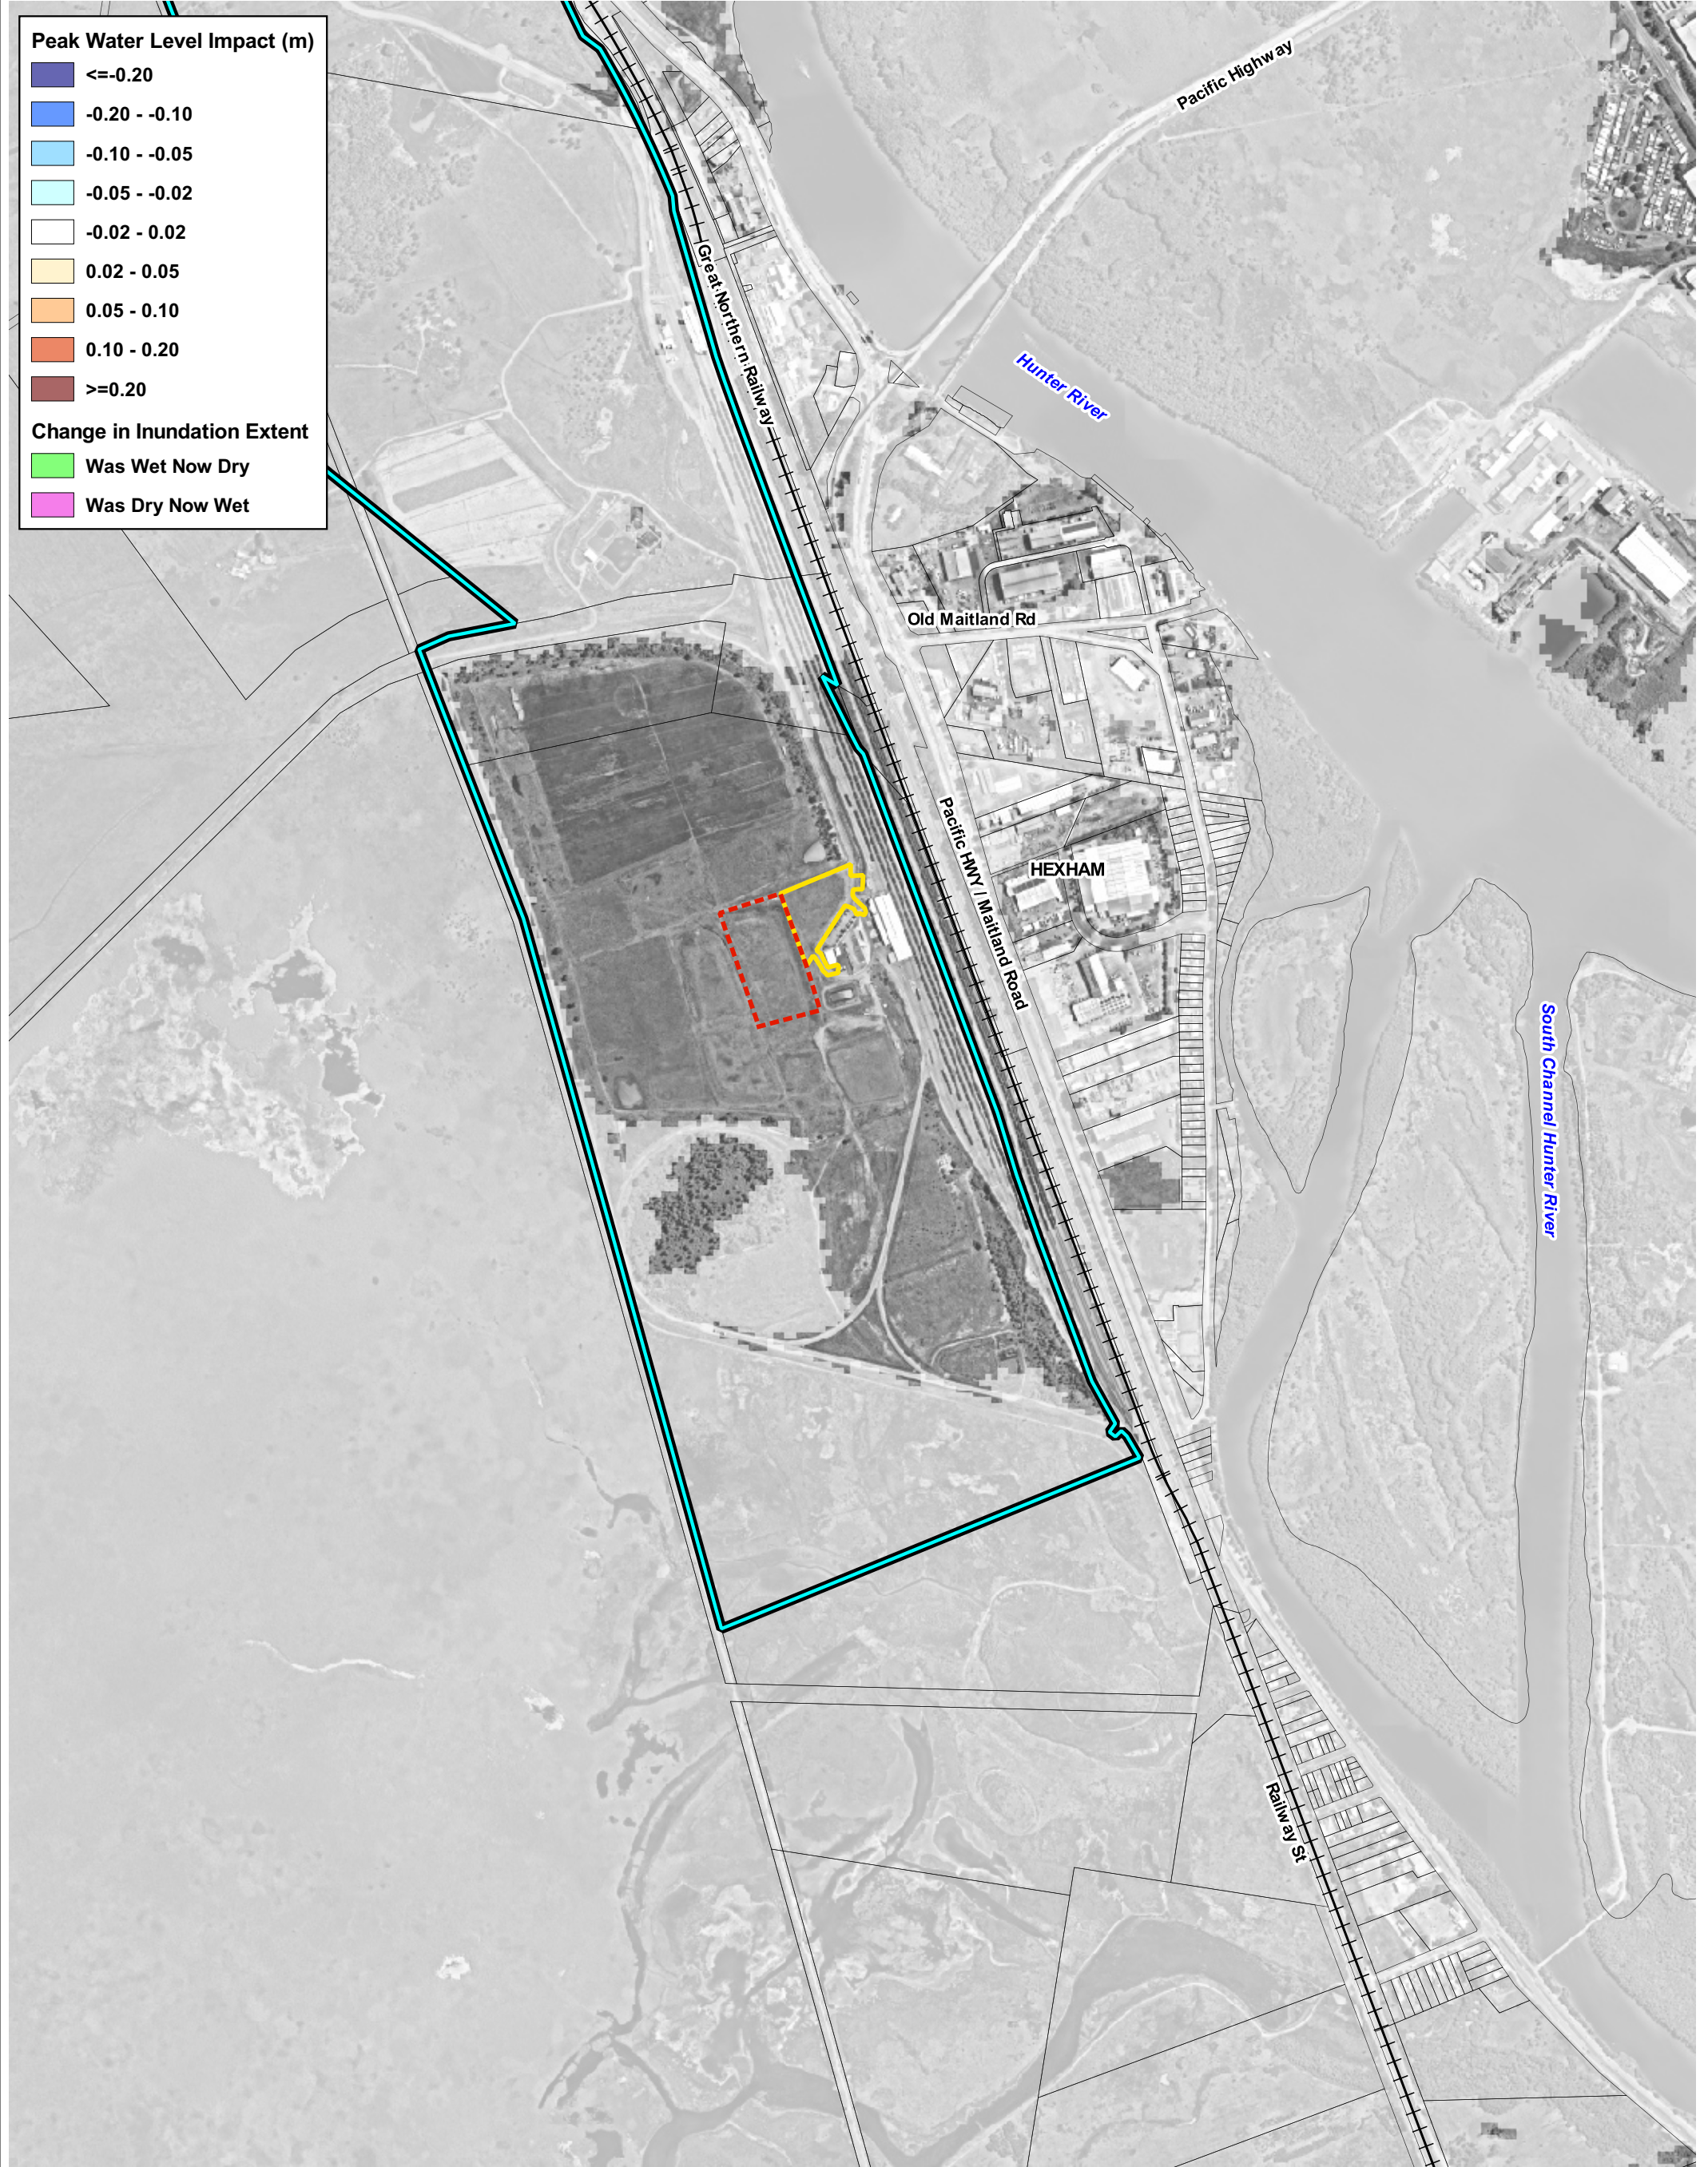
Title: **2% AEP Flood Level Impacts**

Legend	
	The Hexham LTTSF Site
	Proposed Wagon Storage
	Proposed Depot, Warehouse and Carpark
	Cadastral Boundaries
	Railwayline

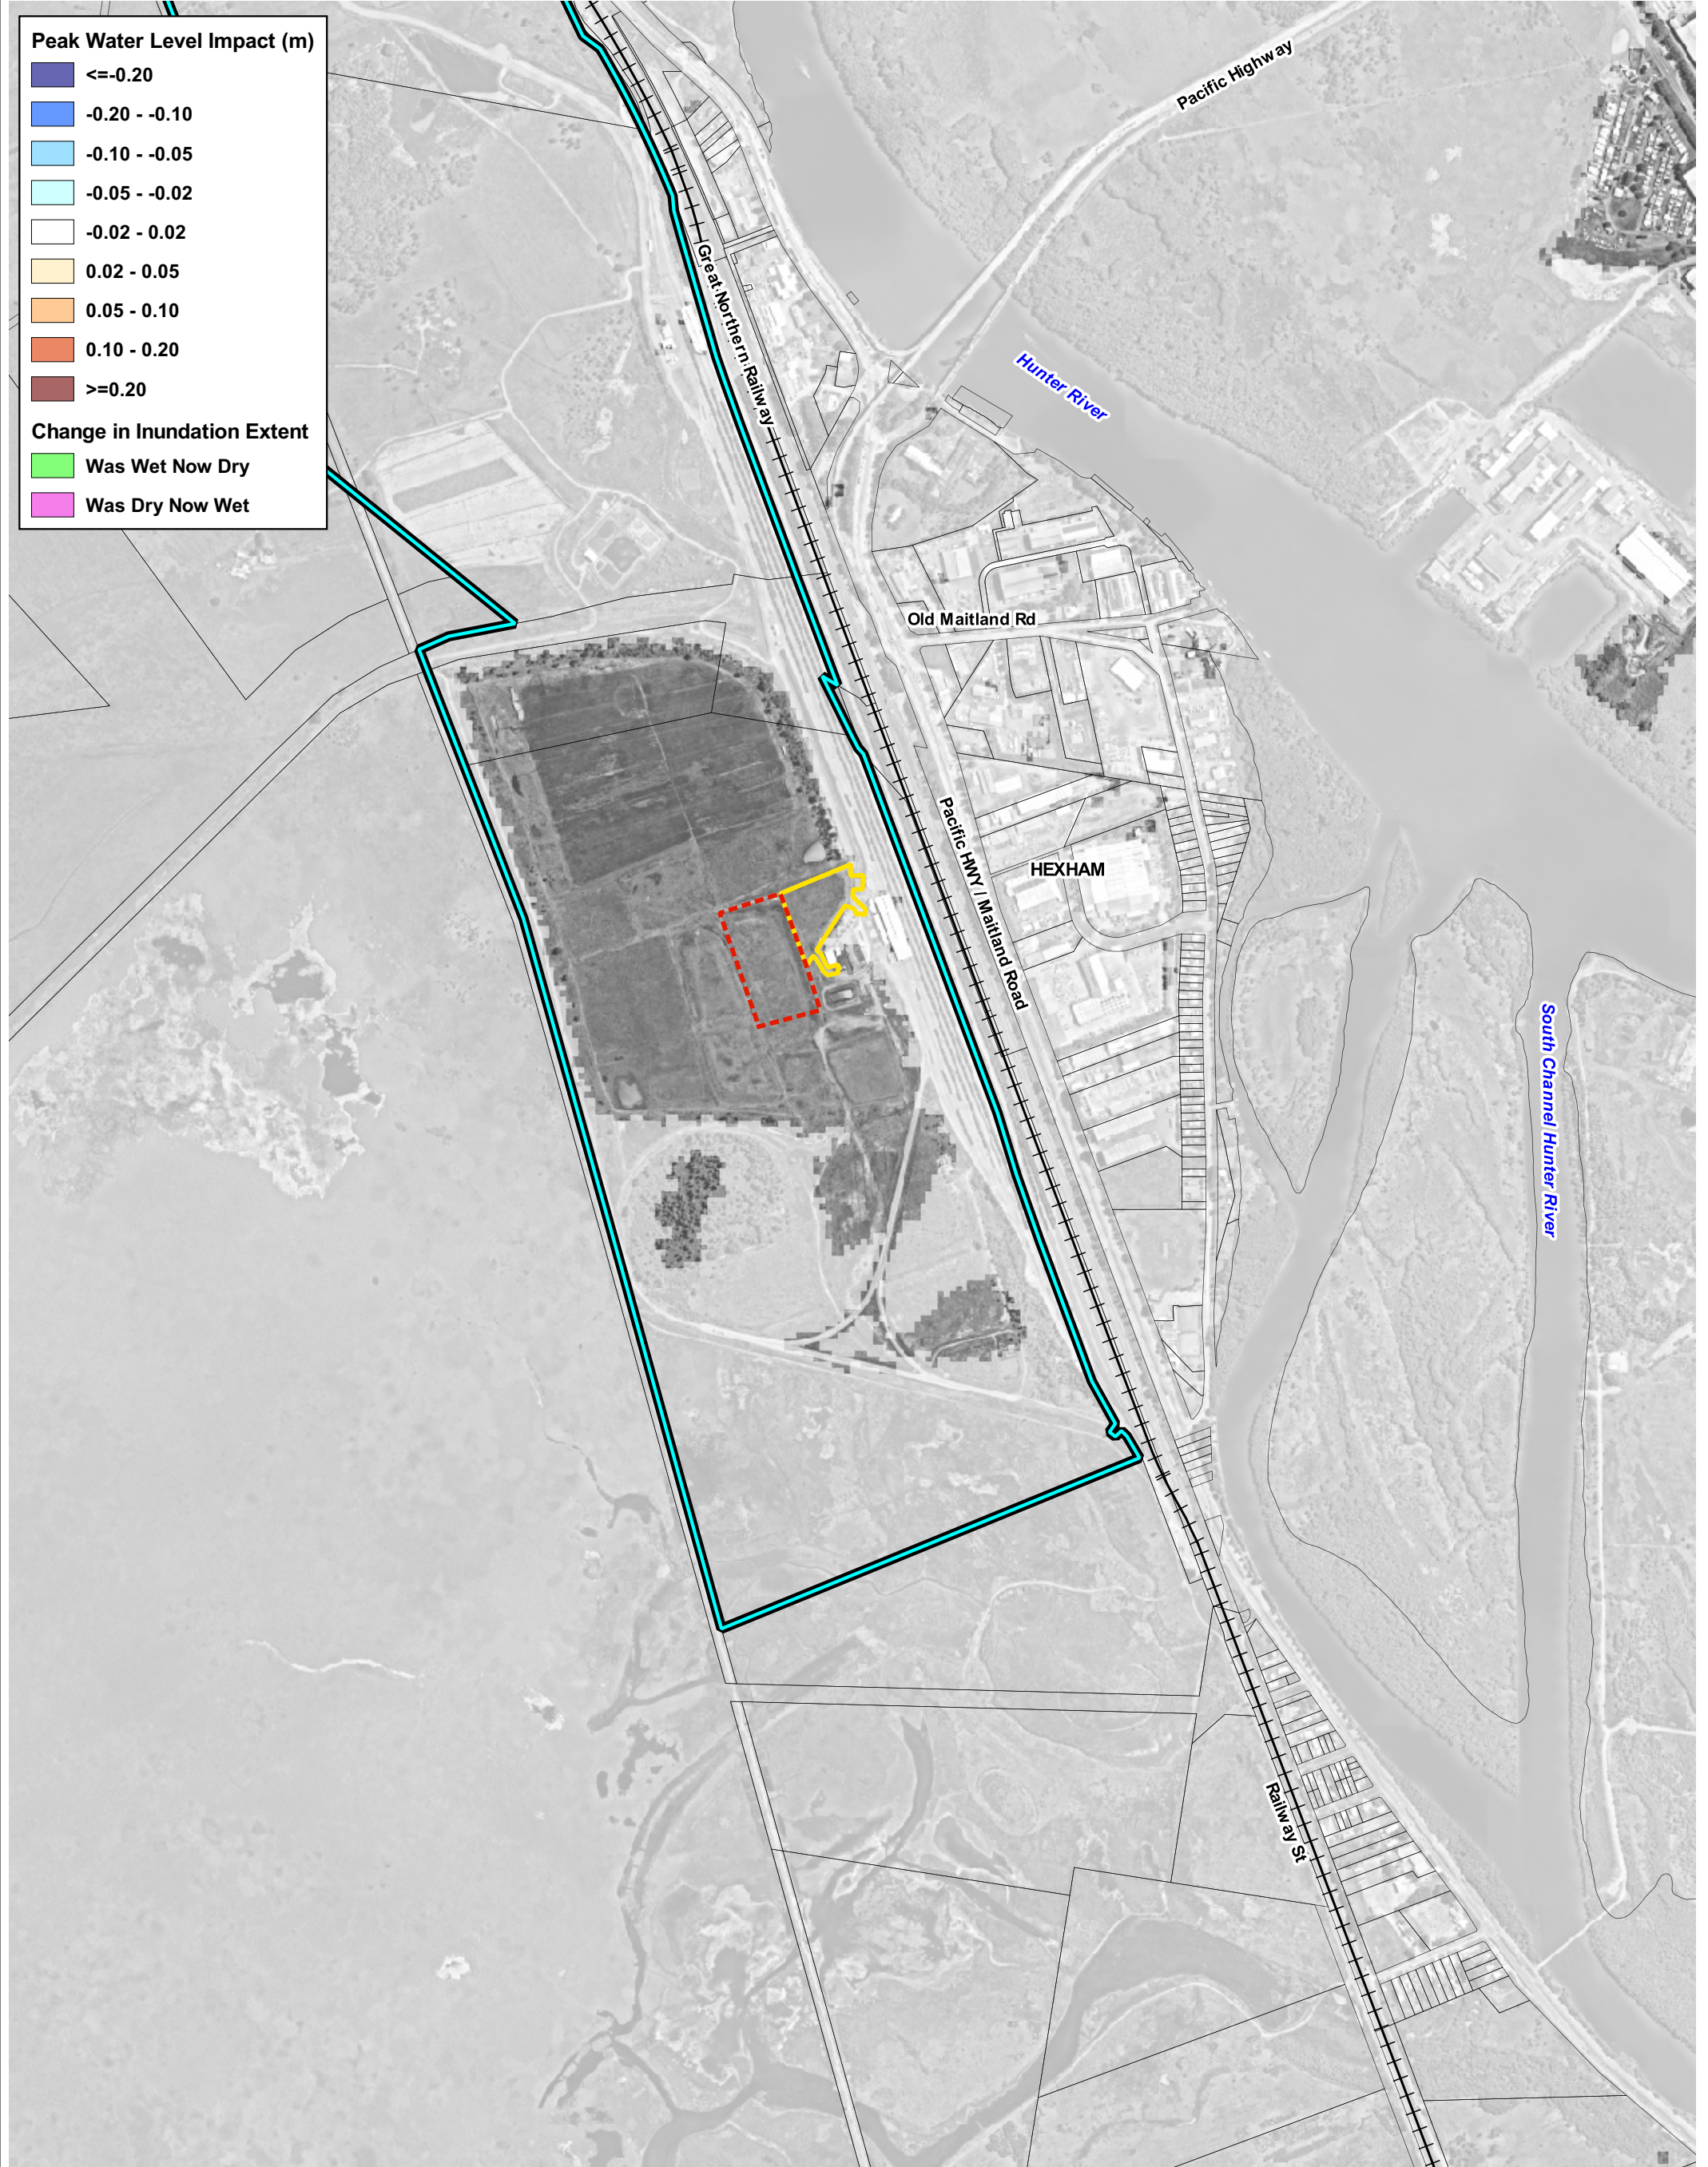
Title: 1% AEP Flood Level Impacts	
BMT endeavours to ensure that the information provided in this map is correct at the time of publication. BMT does not warrant, guarantee or make representations regarding the currency and accuracy of information contained in this map.

Legend	
 	The Hexham LTTSF Site
 	Proposed Wagon Storage
 	Proposed Depot, Warehouse and Carpark
 	Cadastral Boundaries
	Railwayline
